The consequences of operating EWPs on inclines, soft ground and unsupported surfaces.

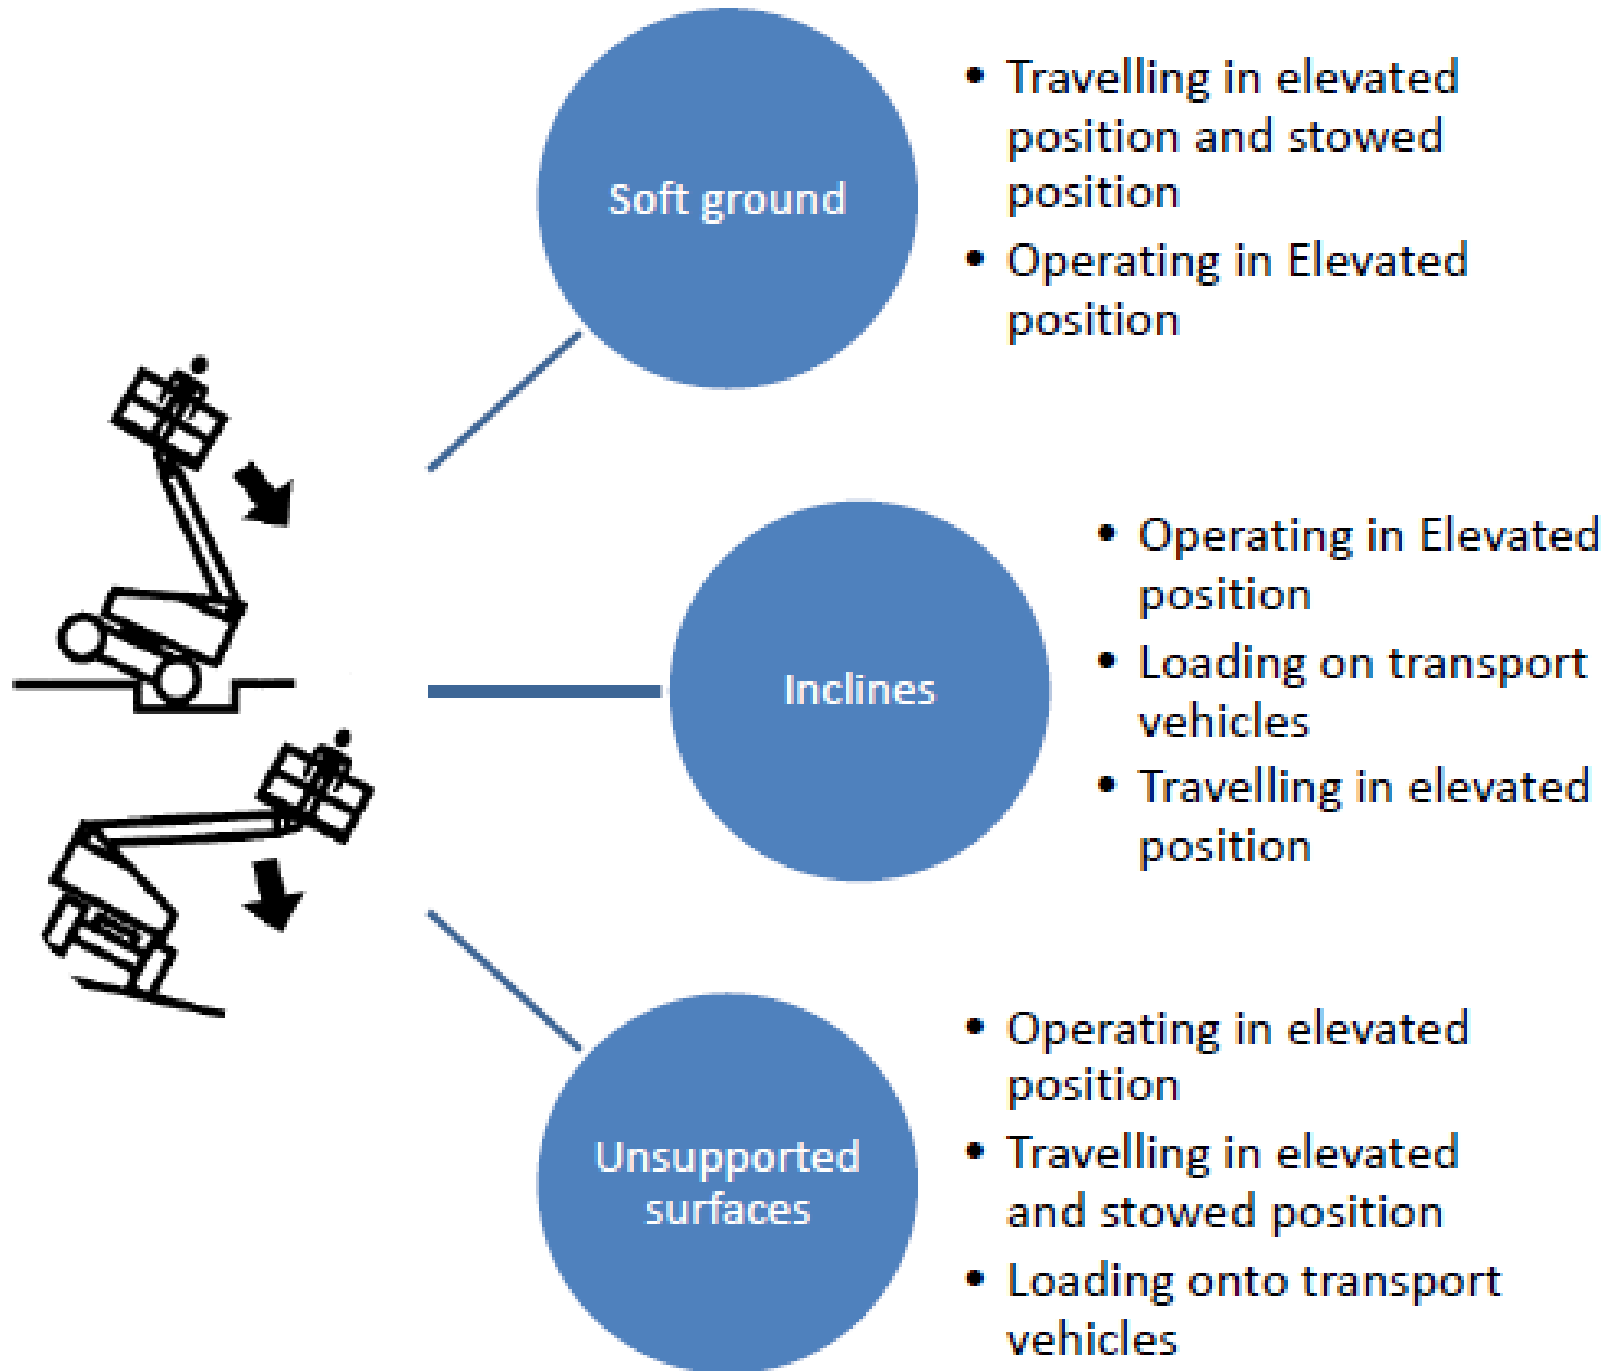
Soft Ground. Fatality . Europe.

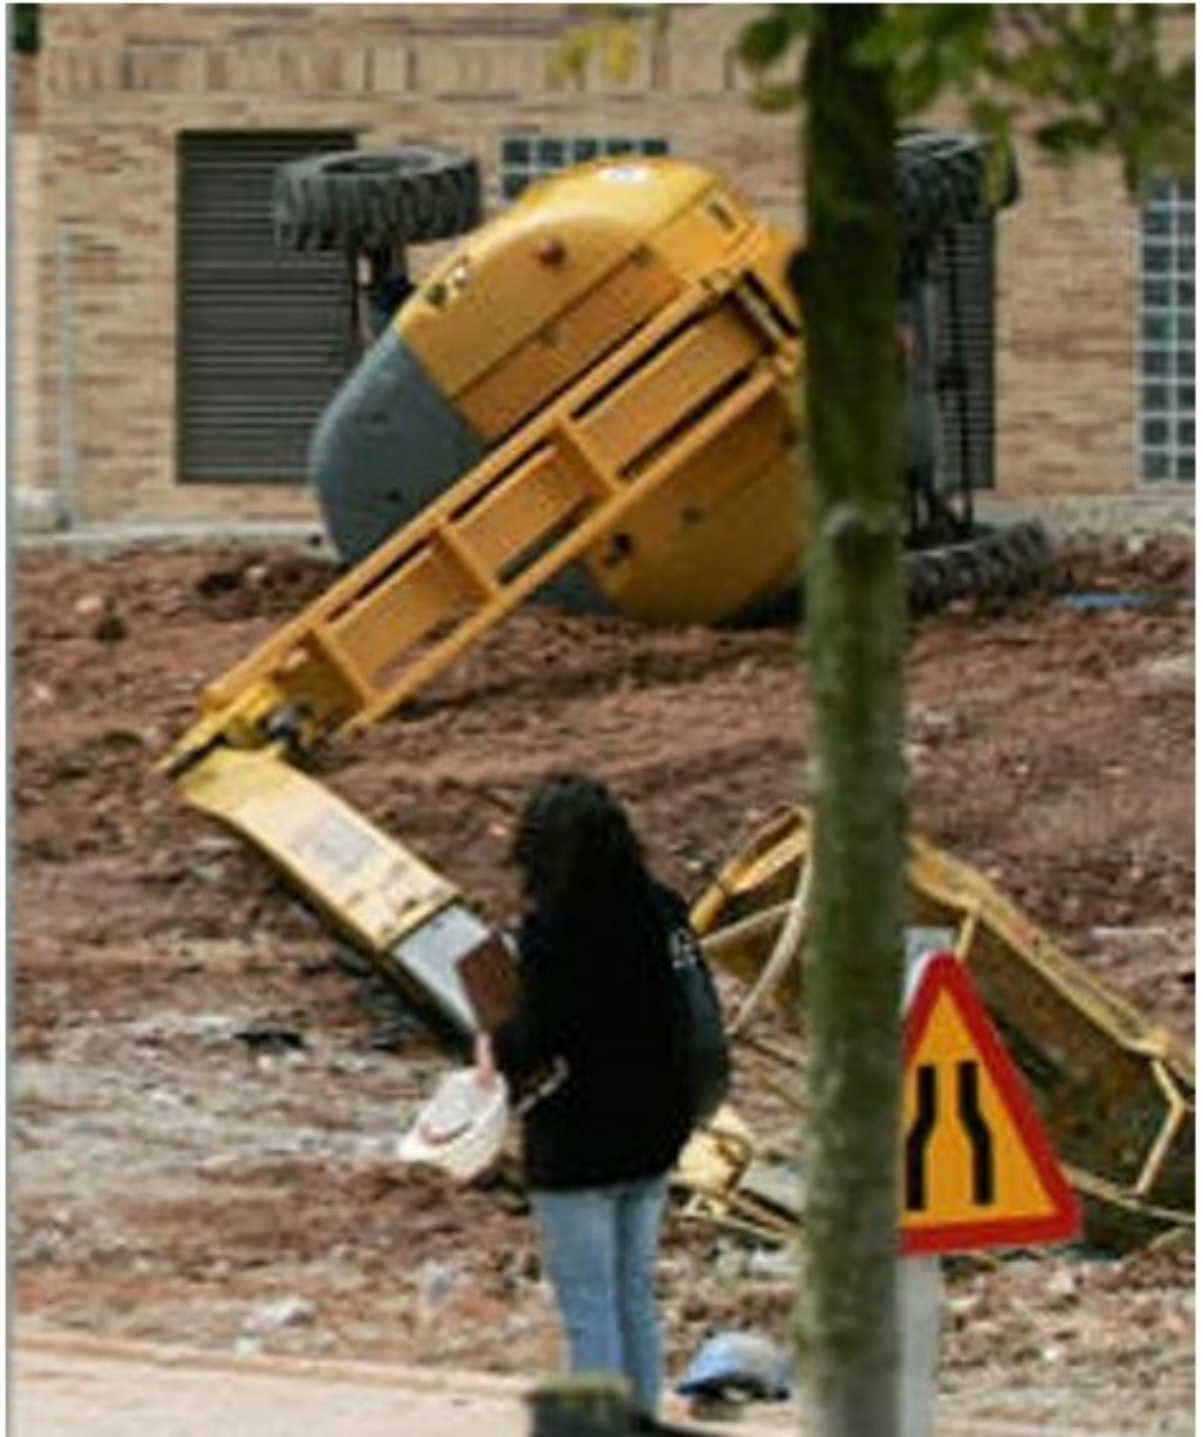
Unsupported surface.
Wheel into void.
Rescued operator.
Europe.

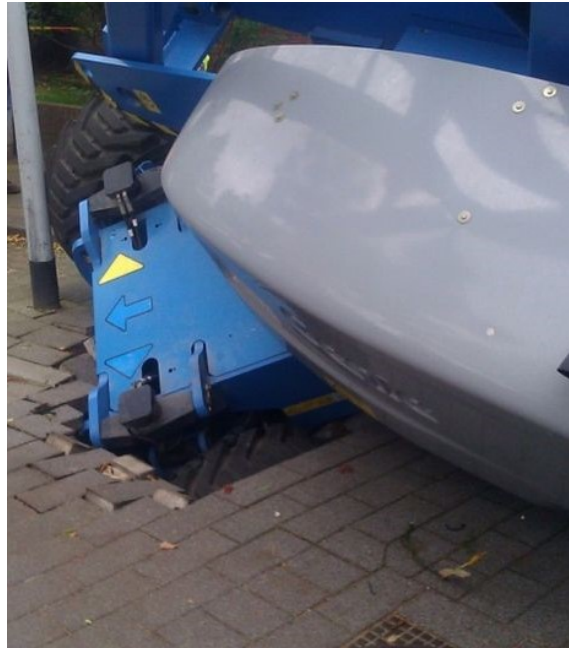
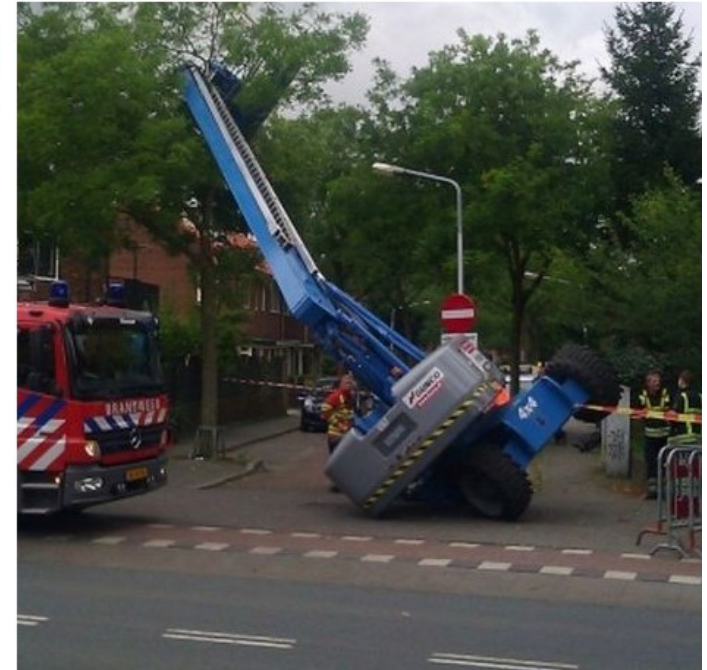
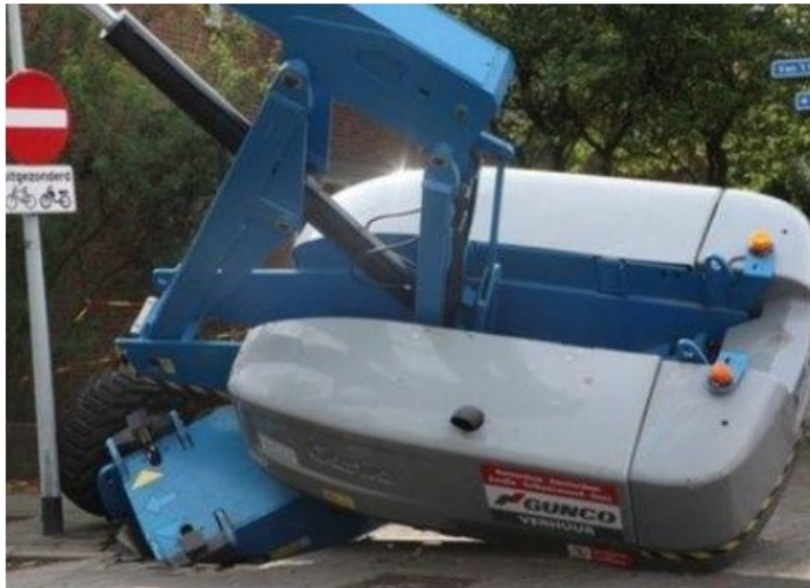
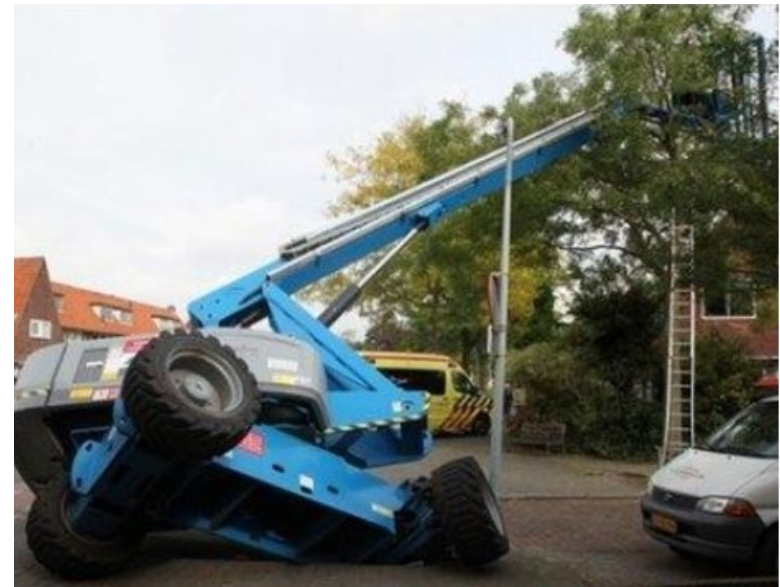
Broke through underground void. one fatality from catapult effect, other operator rescued. Australia.

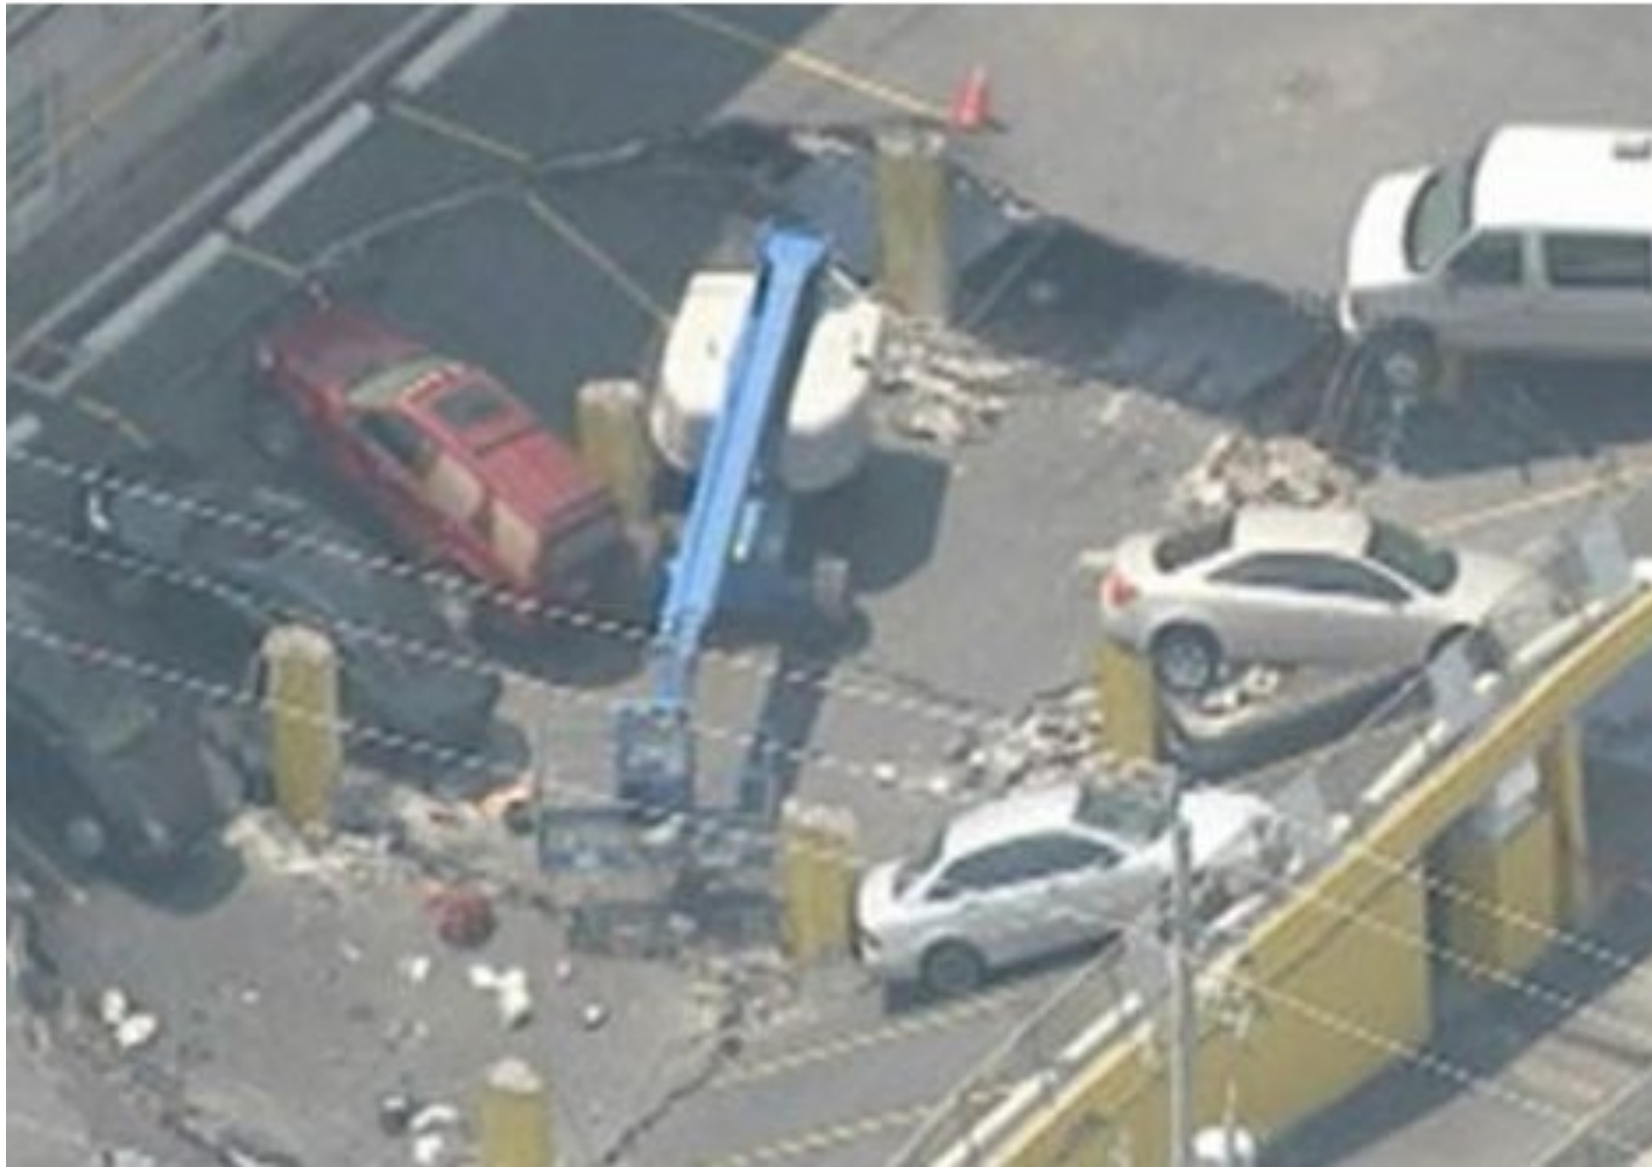
Soft ground.
Catapult.
Fatality.
USA.

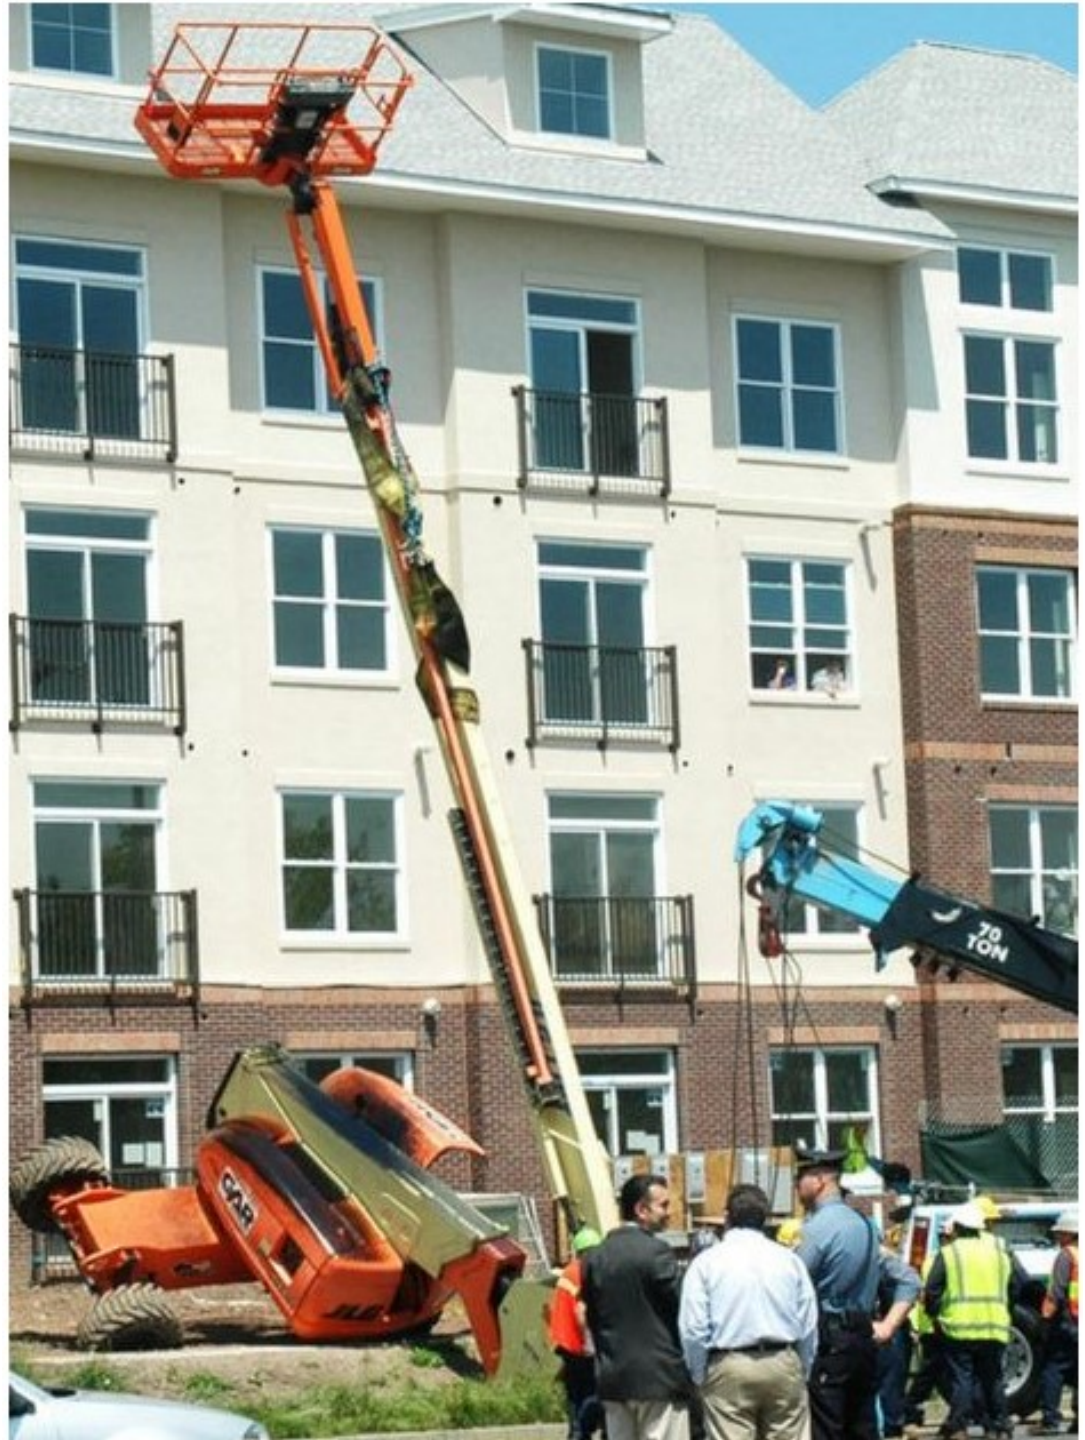
Soft Ground.
Catapult
effect.
Injuries.
Europe.

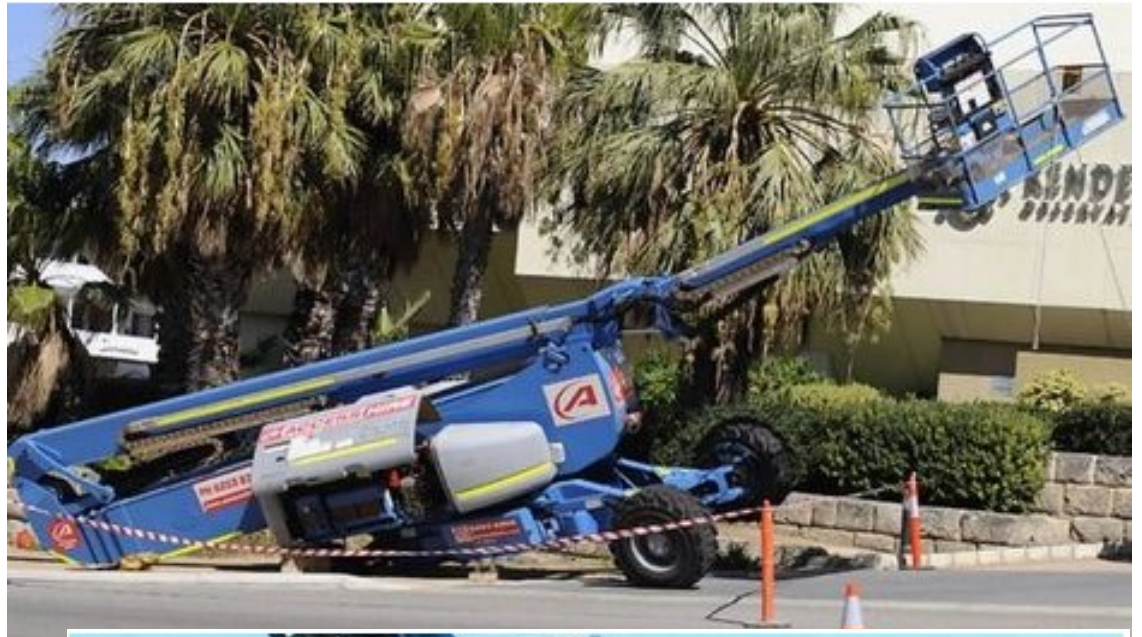
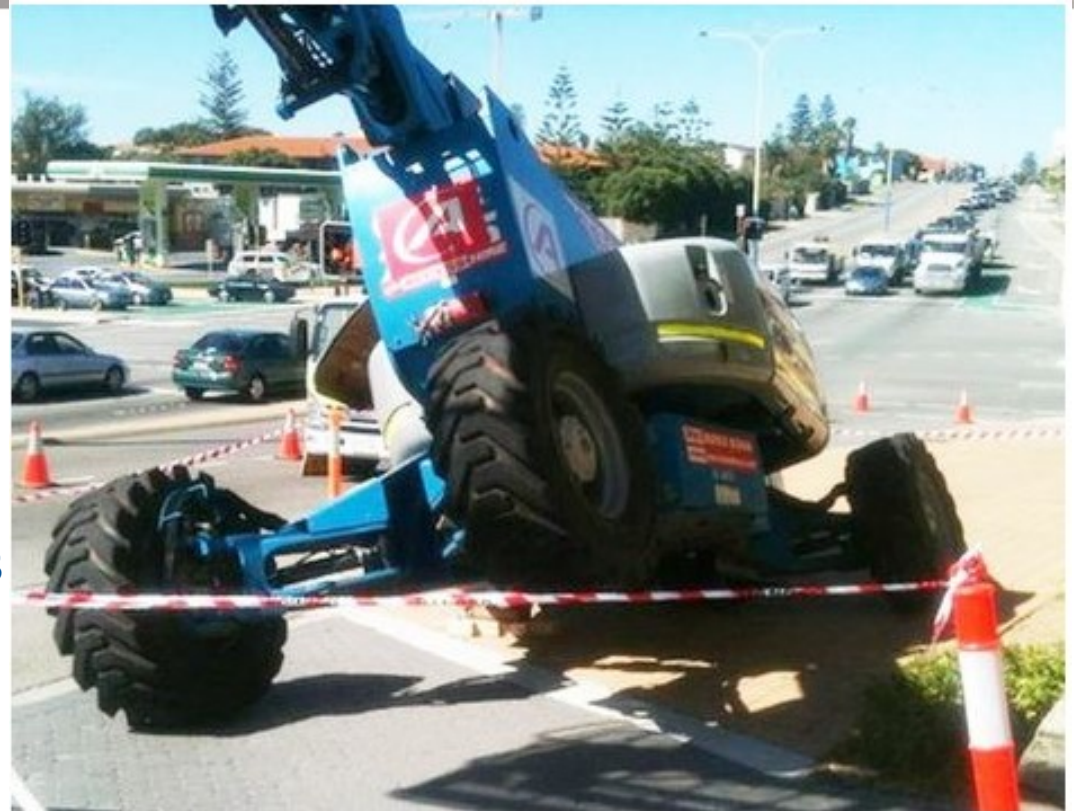
A boom lift overturned earlier today in Roosendaal, the Netherlands when the ground - gave way under one of its wheels.

With wheel loadings on a boom of this size easily exceeding four tonnes – concentrated by the unyielding poly filled tyres – it can prove to be too much for the interlocking blocks to support.

1 Injured operator. Netherlands.

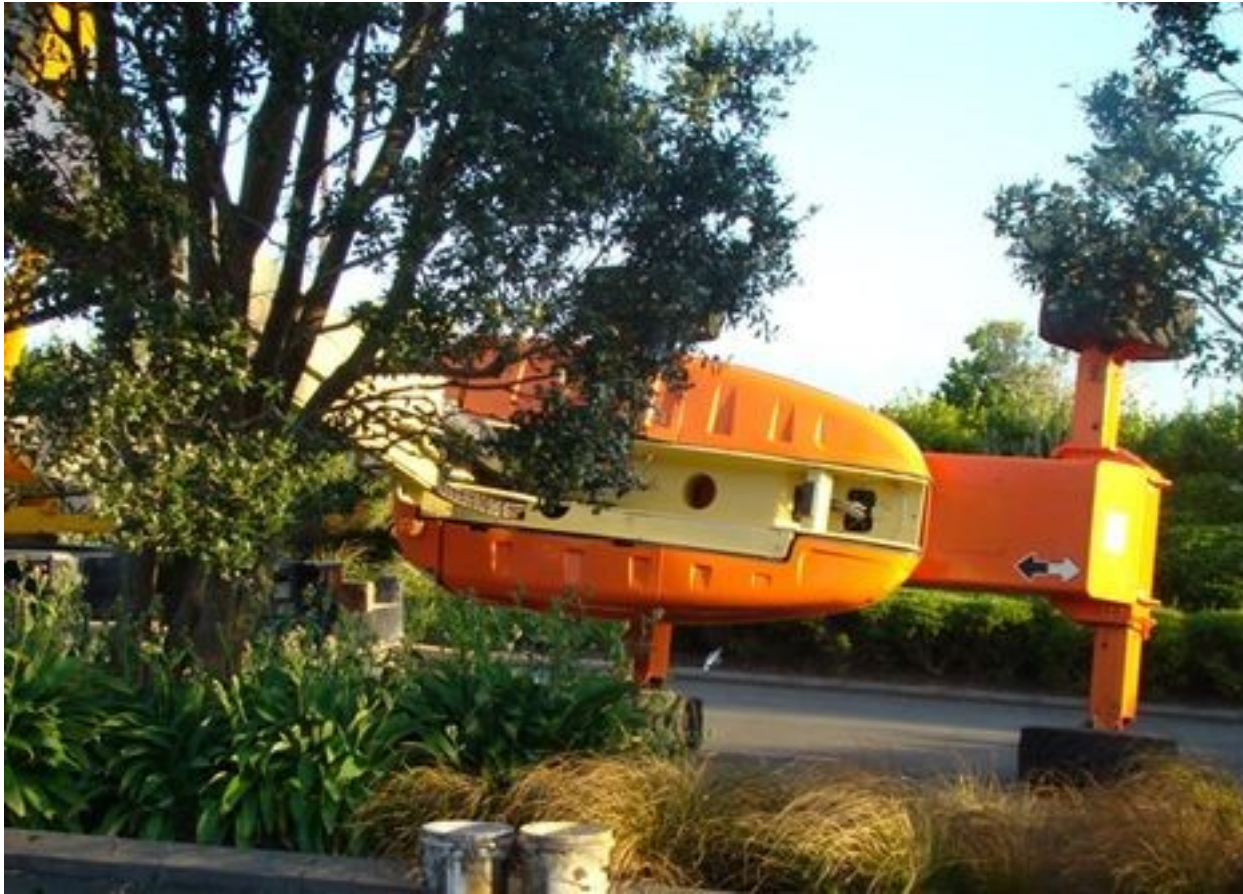
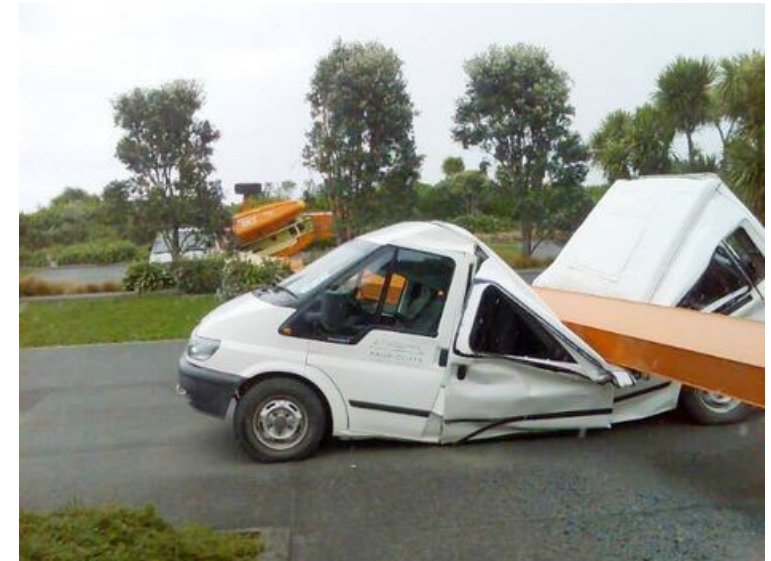
A golf tournament was being broadcast at the time and the boom was being used to raise a communication antennae in order to get a clear signal over the nearby cliffs. The antennae were located on the platform and the boom was fully raised and fully extended with the superstructure slewed over the side. A freak gust of wind of over 70 knots, a category 1 hurricane, 129kph / 81mph/ Beaufort scale 12 , caught the machine head on, which combined with the lack of weight in the platform and the fully raised boom caused it to go over backwards. Property damage only. No Injuries. North Island, New Zealand.

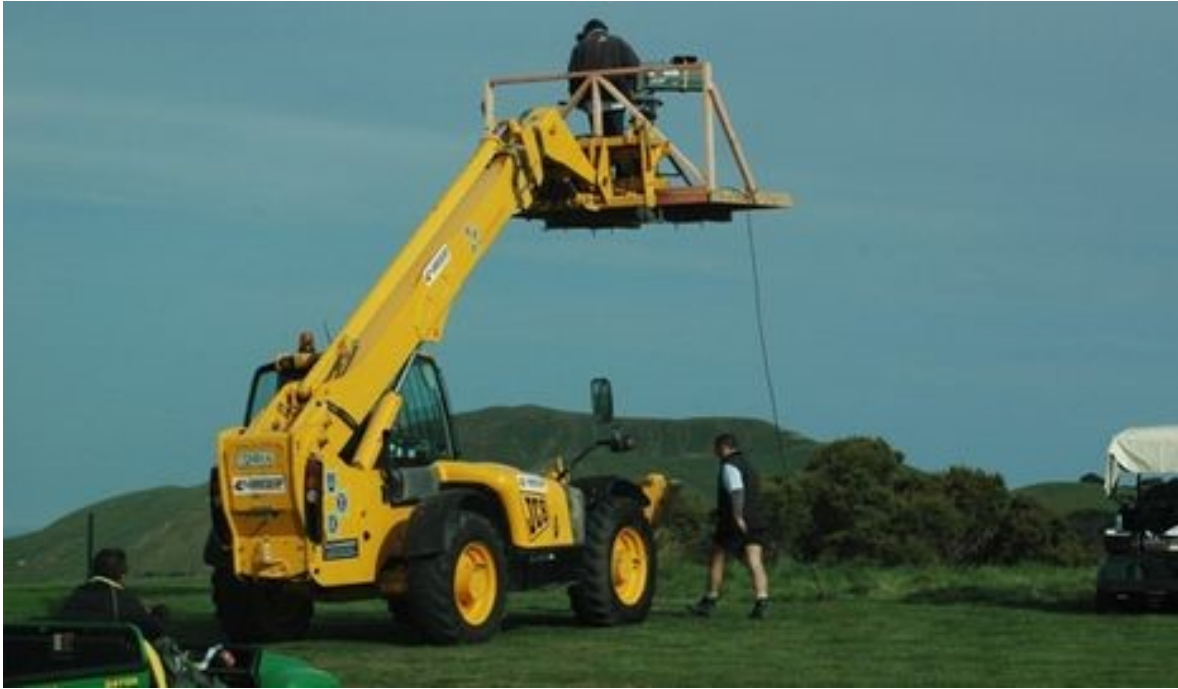
The North American camera team rented a lift to serve as a high level camera stand for the same golf tournament, the Kiwi Golf Challenge, in which a fully extended 135ft boom lift tipped over crushing a minibus. It is surmises the fact that the Camera Crew were from 'out of town' was a factor in them accepting and using improvised equipment that would not be acceptable elsewhere in the developed world !

No Harness, outriggers up, bolted wooden pallet.

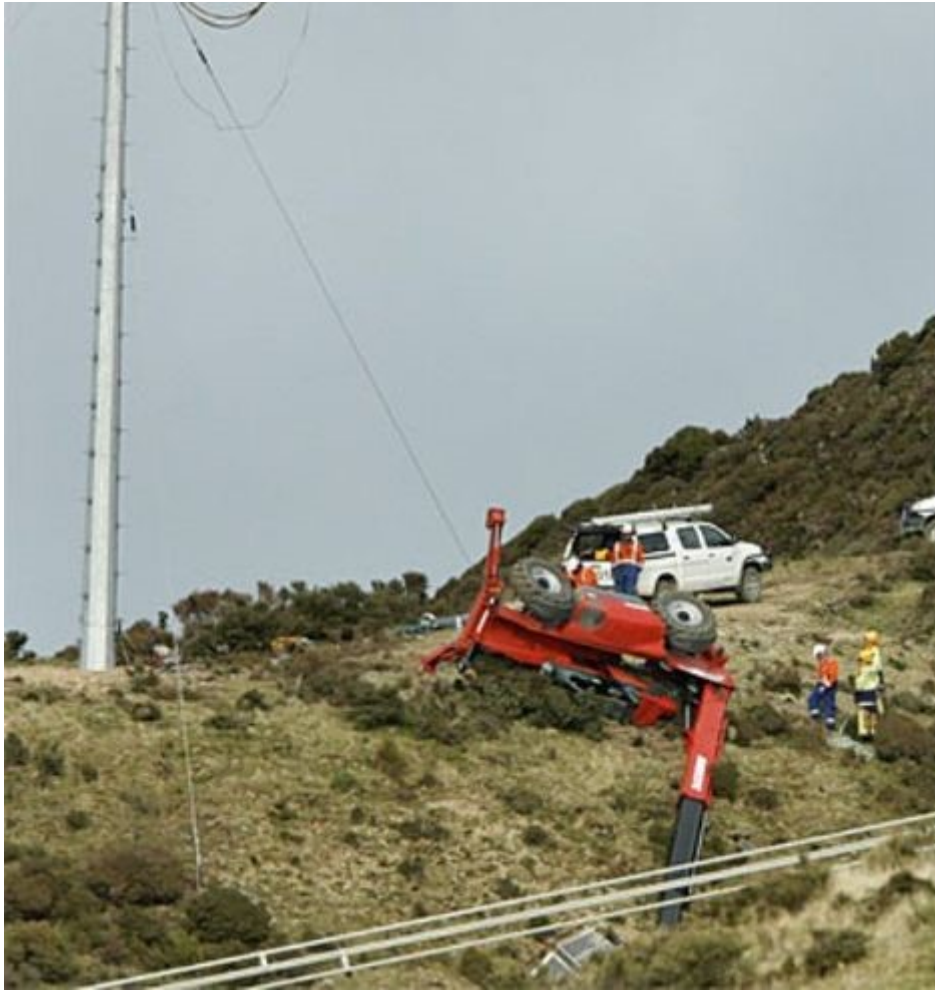
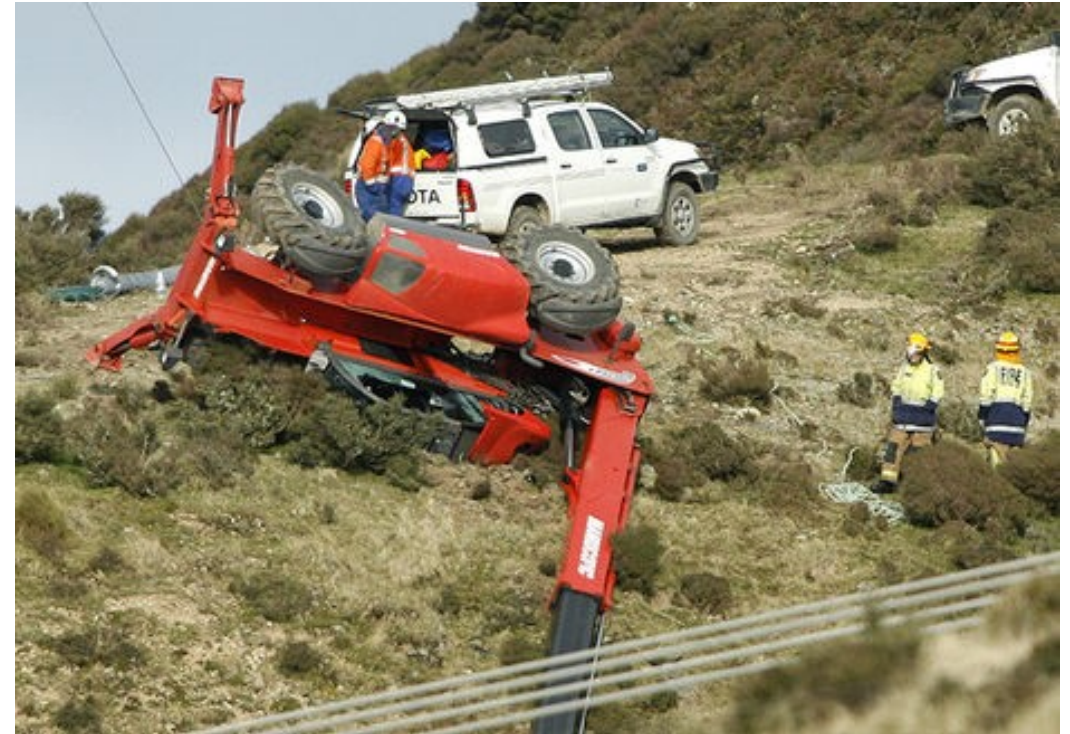
Two men were working from a platform around 10 metres up when the lift ran away and/or overturned. The men were properly harnessed and tied in, but the overturning caused fatal injuries to one man, while the other has been airlifted to hospital.
