Safety alert 14/2012

Elevating work platform fatality

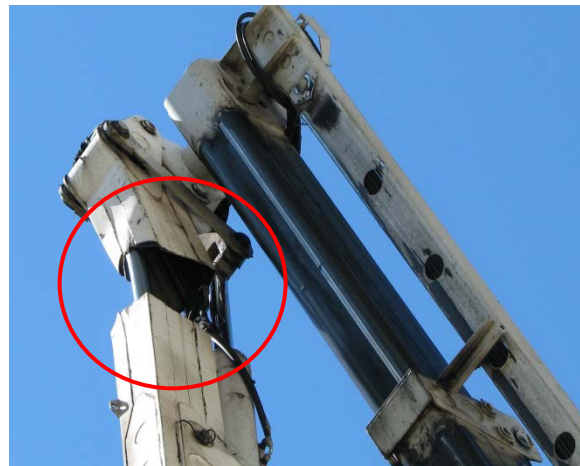
An operator was killed when the jib supporting the bucket of the EWP he was operating failed, causing him to fall approximately 20 metres with the bucket. The EWP was an Italmec model Ital Jib 42N. The failure occurred between the jib luffing ram attachment points.

- Angle fishplates had been welded to each external corner of the hollow jib section.
- The failure was located at the end of one of the angle fishplates on the bottom face of the jib.
- A metallurgical examination indicated the angle fishplate welding was associated with the failure.

Figure 1 Area of jig failure

1. All Italmec EWPs to undergo radiographic testing of their boom and jib welds.
2. Remove from service any EWP identified as unsafe until all defects have been corrected under the supervision of an engineer.
