Consequences of Operating MEWPs on Inclines, Soft Ground and Unsupported Surfaces

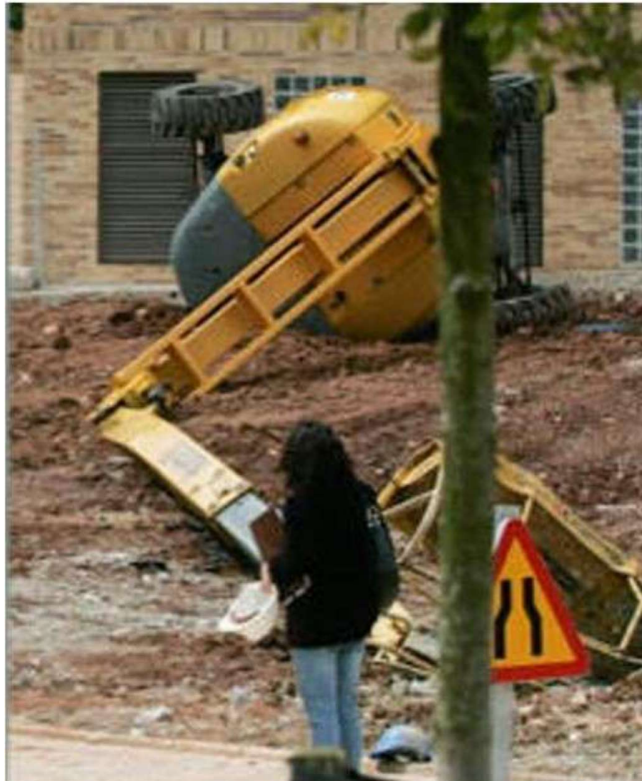
- Soft ground - one side of the MEWP began to sink causing it to overturn, the operator remained in the platform and was crushed when it hit the ground.
- Fatality
- Spain

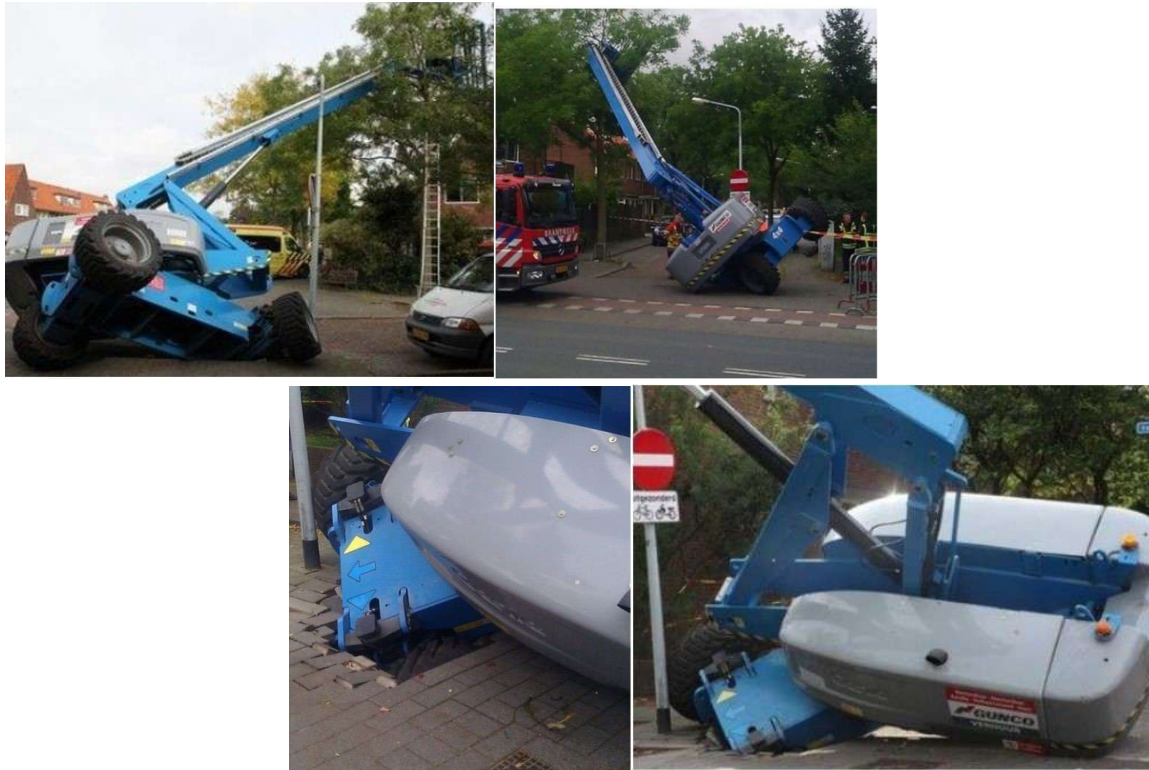
- Unsupported surface – one of the front wheels punched through the block surface and into a large void, the operator was not wearing a harness and had a ‘lucky’ escape in the way the machine fell and himself falling into branches of the tree.
- Rescued operator
- Netherlands

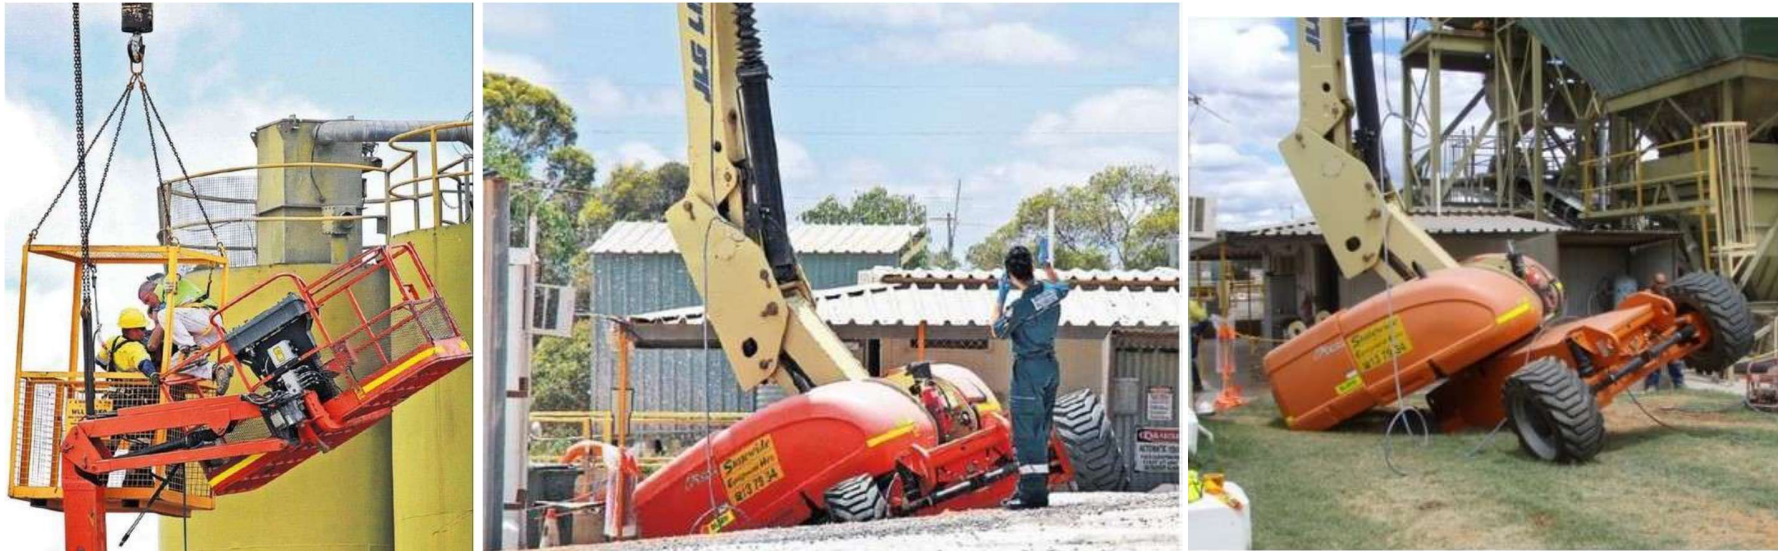
- Broke through underground void – possibly a large drain under the grass surface the MEWP was travelling on, the MEWP was unstable and emergency lowering could not be used to bring the surviving operator down. One operator was wearing a harness attached to an anchor point and was rescued by a crane. It is assumed that the other operator was wearing a harness which was not attached to an anchor point.
- One fatality from catapult effect, the other operator rescued.
- Australia.

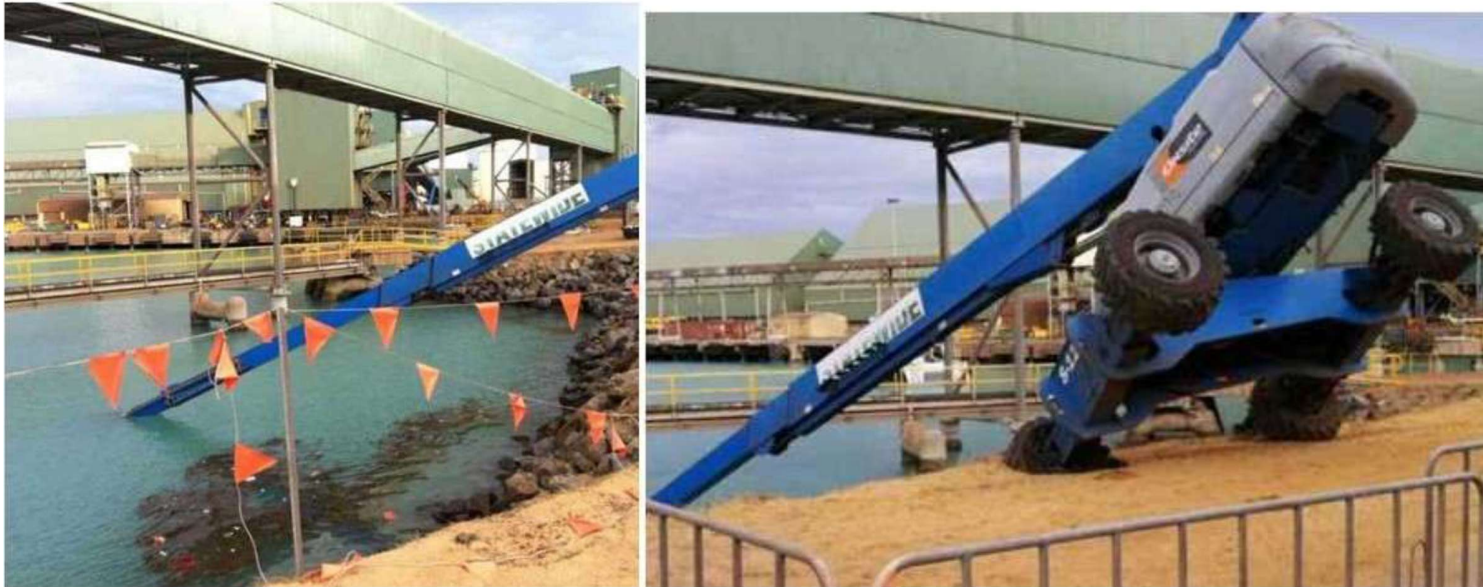
- Soft ground - the boom's wheels sank into the soft ground, causing the machine to overturn and the platform to be submerged in water. While this provided a softer landing, it also posed the risk of trapping the operators due to their lanyards.
- The operators disregarded key safety advice and training, which instructed them not to use a harness and lanyard over water and to wear a life vest. Fortunately, they were able to unclip themselves and swim to safety.
- Rescued operators
- Australia

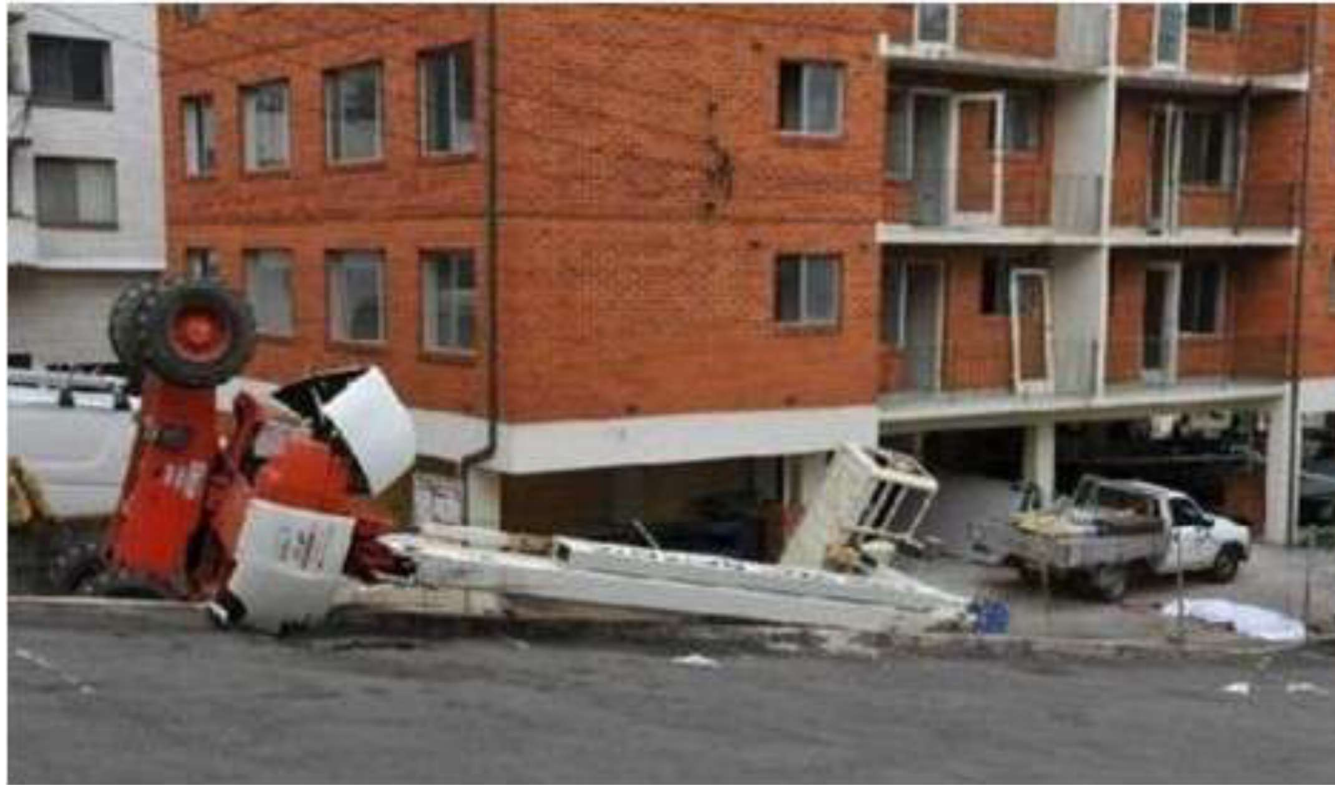
- Slope and steep incline - excessive backward incline. MEWP tipped over backwards and rolled over side-ways into driveway.
- One fatality
- Australia

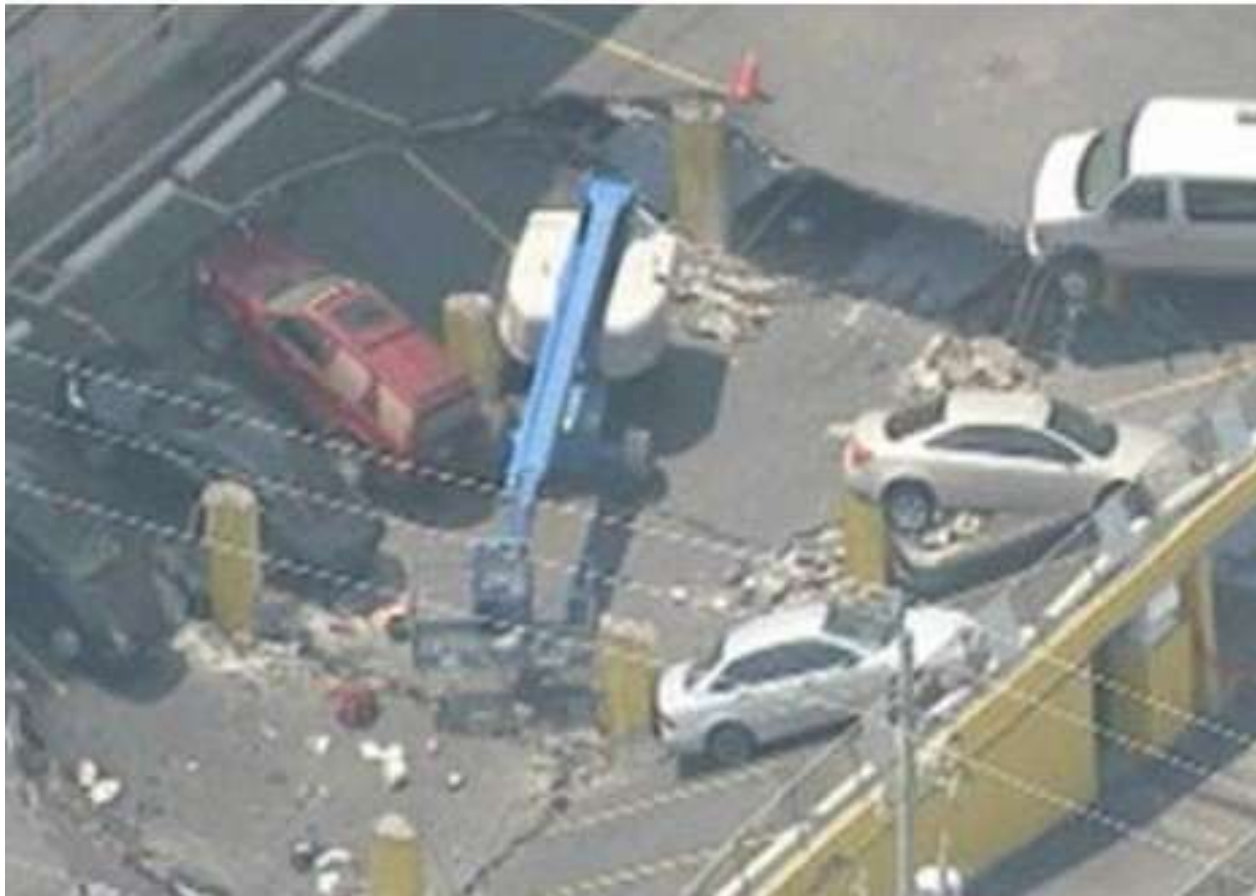
- Floor load exceeded causing the structural collapse of a carpark. Luckily there was no-one on the ground floor of the carpark.
- Rescued operator
- USA

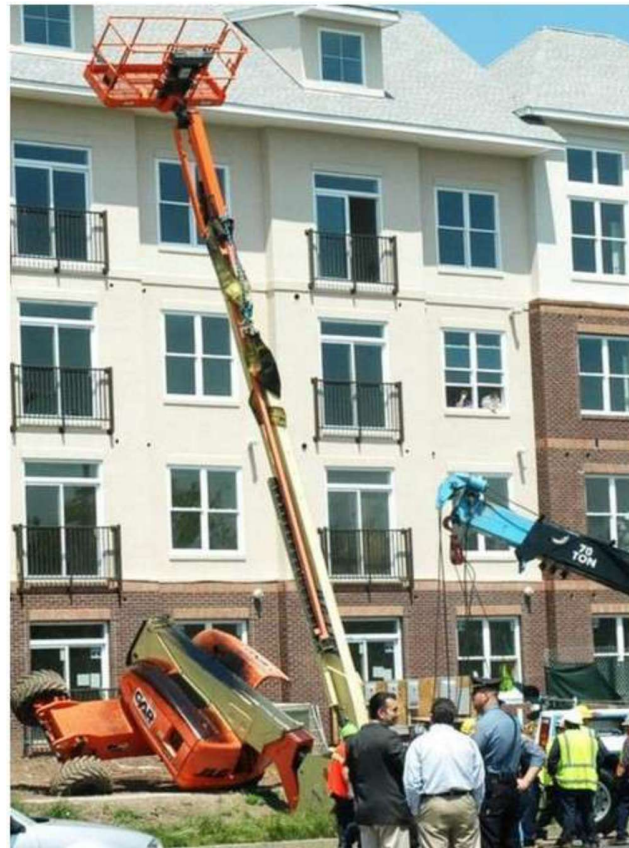
- Soft ground – the wheels on the one side of the MEWP sank as the ground gave way. The operator who was not wearing a harness was catapulted from the basket.
- Fatality
- USA

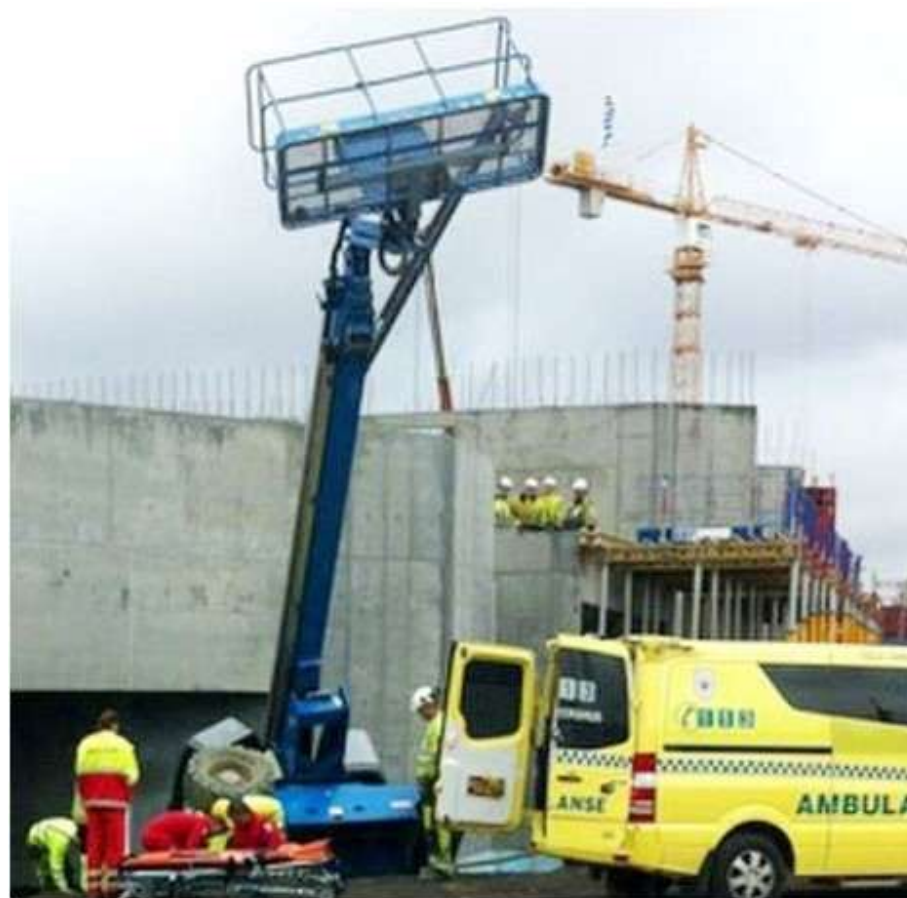
- Soft ground – the MEWP became stuck in soft ground on the edge of an excavation. The operator was trying to get the machine ‘unstuck’ and slewed the platform over the side with the counterweight pointing in the direction of the excavation, the left side slipped and dropped causing a massive catapult effect.
- Operators injured
- Norway

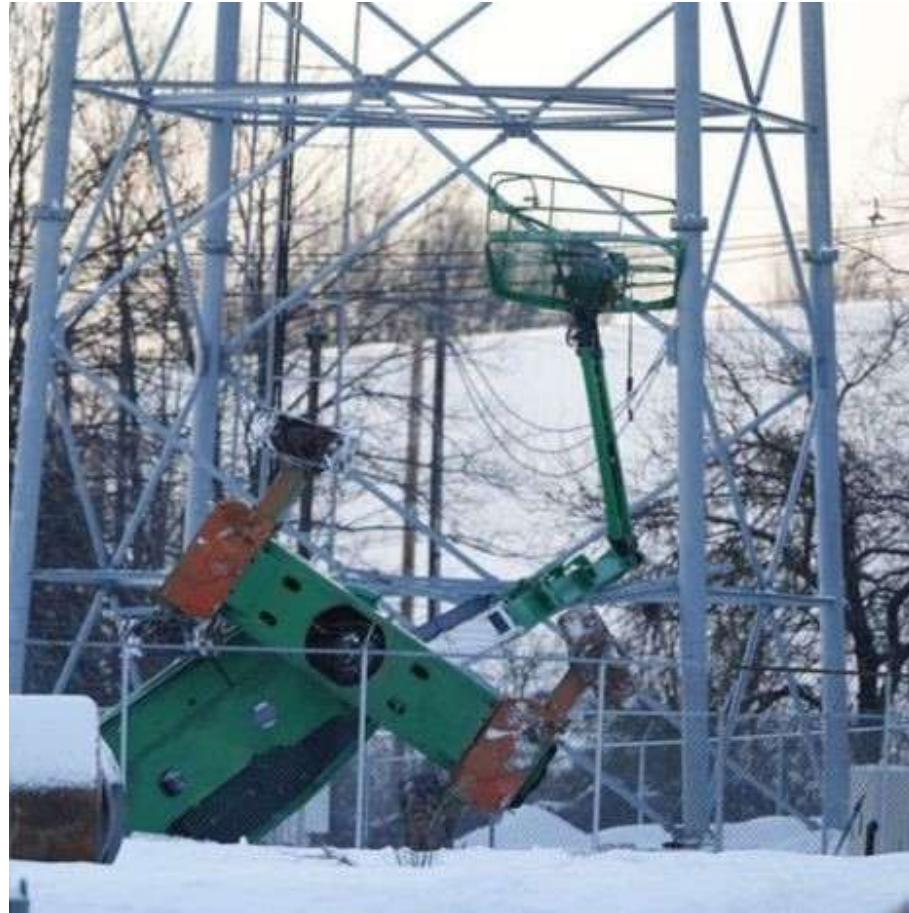
- While the exact cause of the machine overturning is unknown, the fact that it was operating in deep snow, which can conceal ground conditions such as slopes and voids, provides a possible clue.
- Operator rescued from dangling in harness
- USA

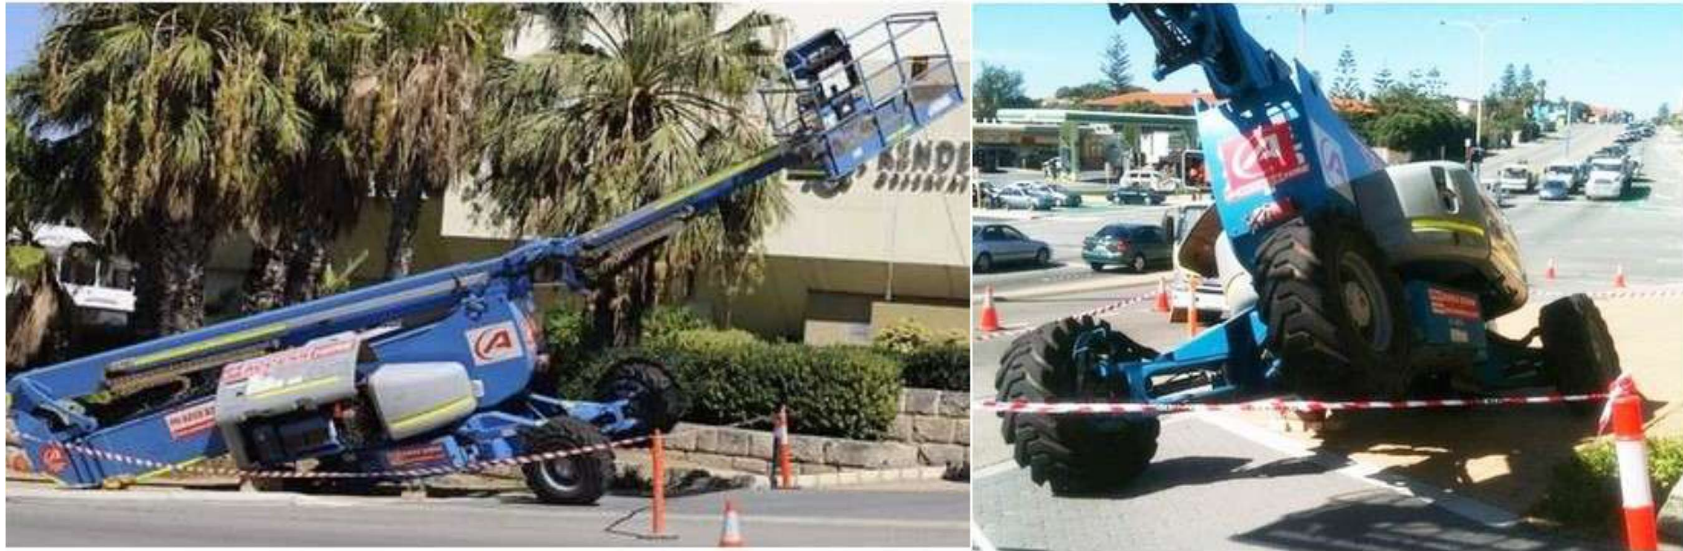
- Unsupported surface - the electric culvert cover collapsed under the weight of the MEWP causing it to suddenly tip to one side. As the lower boom struck the ground it helped the MEWP from completely overturning. The operator was wearing a harness.
- Operator rescued
- Australia

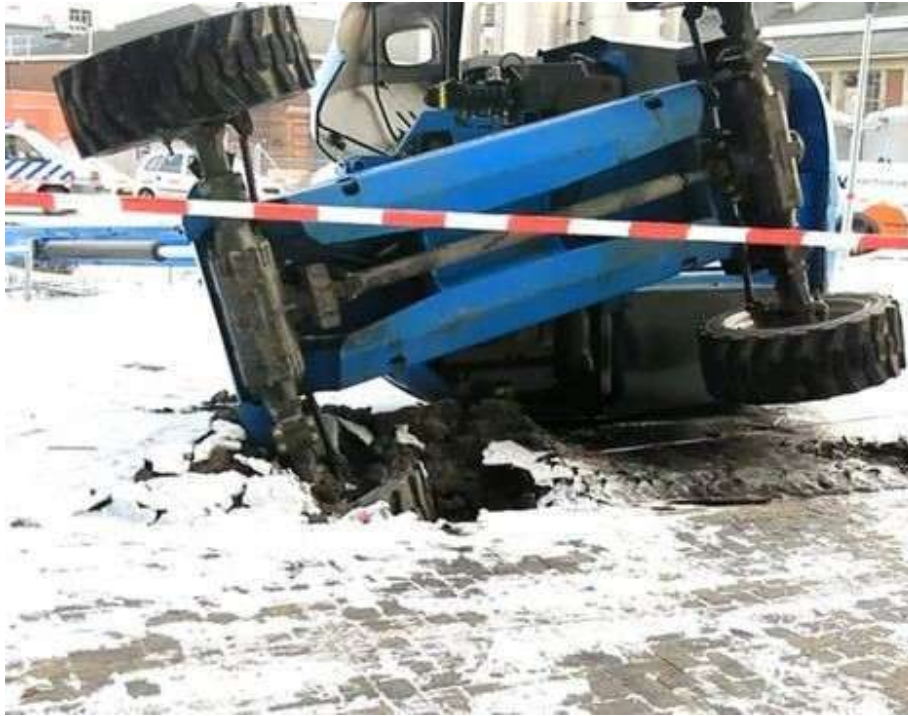
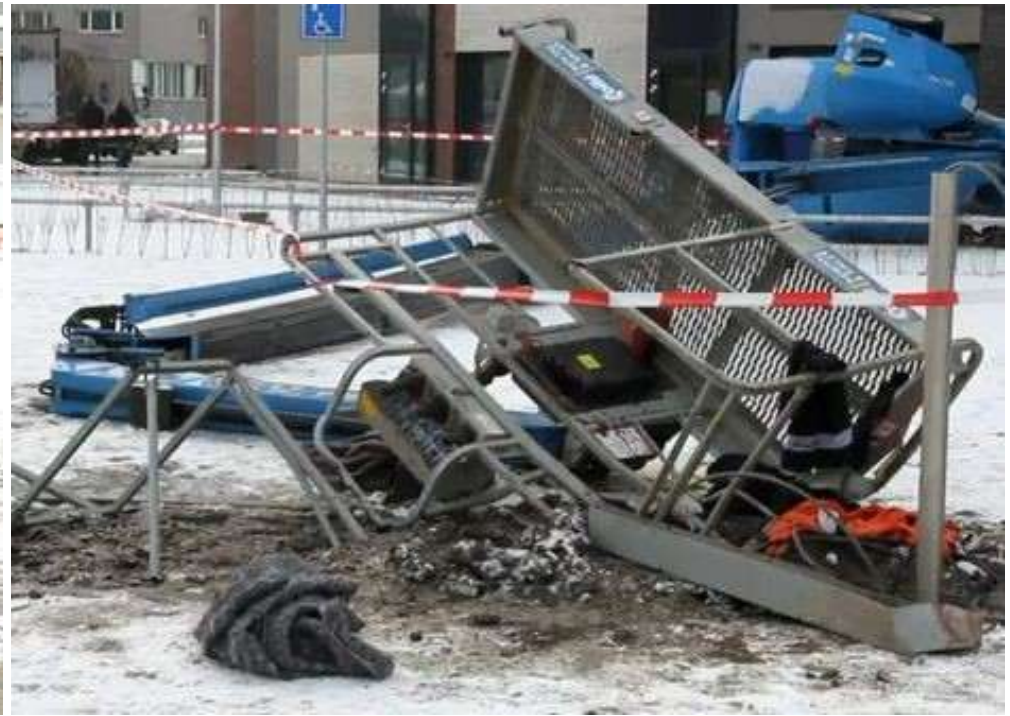
- A boom lift overturned when the ground gave way under one of its wheels. With wheel loadings on a boom of this size easily exceeding 4 tons, concentrated by the unyielding poly filled tyres, it can prove to be too much for the interlocking blocks to support.
- One injured operator
- Netherlands

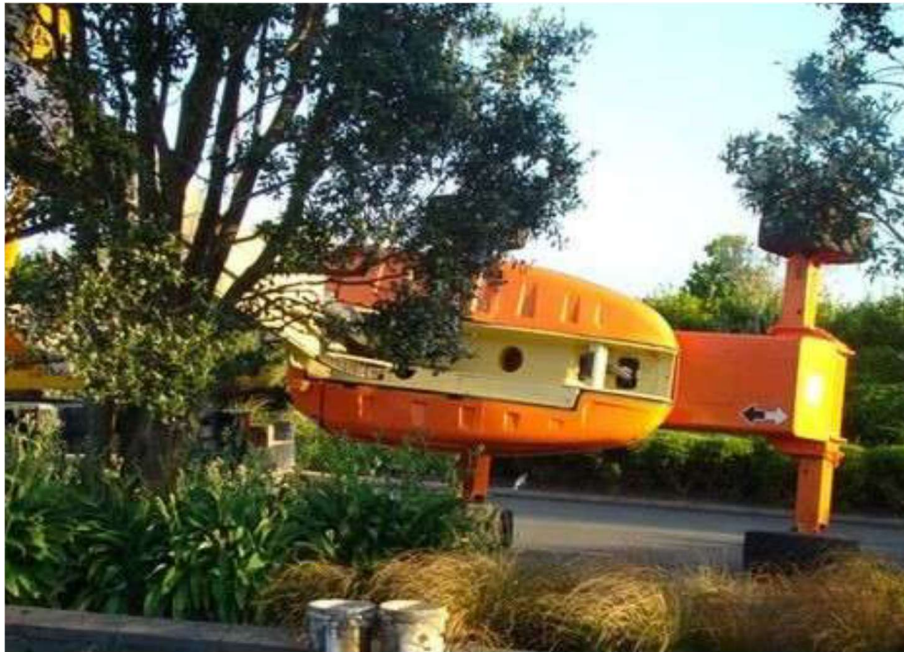
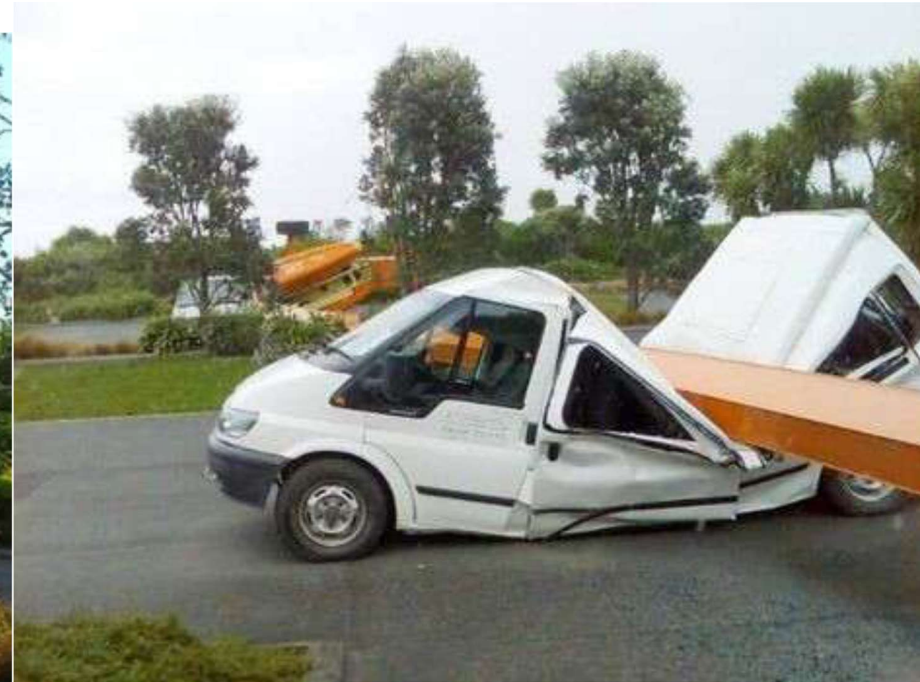
- A golf tournament was being broadcast at the time and the boom was being used to raise a communication antenna to get a clear signal over the nearby cliffs. The antennae were located on the platform and the boom was fully raised and fully extended with the superstructure slewed over the side. A freak gust of wind (over 70 knots) a category 1 hurricane, 129kph / 81mph/ Beaufort scale 12 , caught the machine head on, which combined with the lack of weight in the platform and the fully raised boom caused it to go over backwards.
- Property damaged, no injuries
- New Zealand

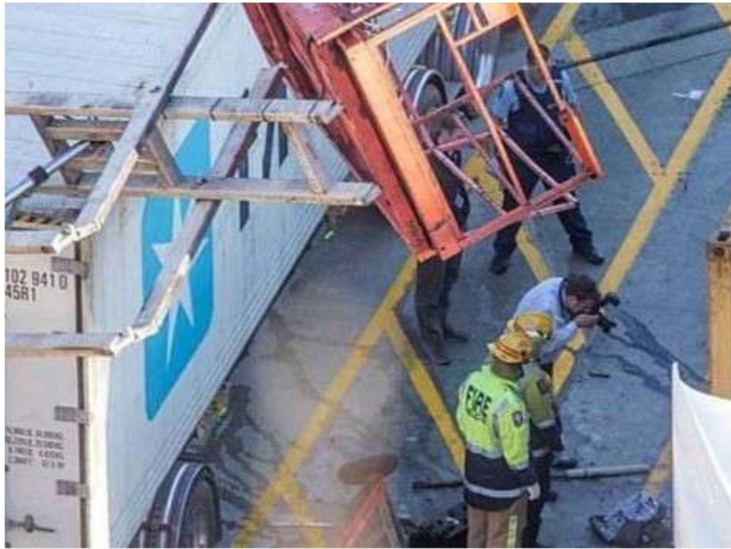
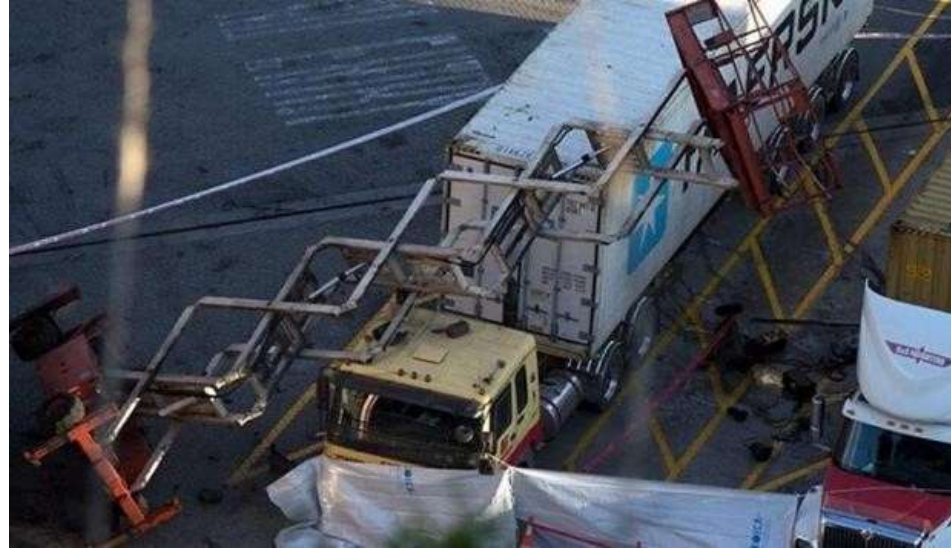
- A man has died at Lyttelton Port, Christchurch, after the scissor lift he was using overturned and landed on a tractor trailer loaded with a container.
- Property damaged, fatality
- New Zealand

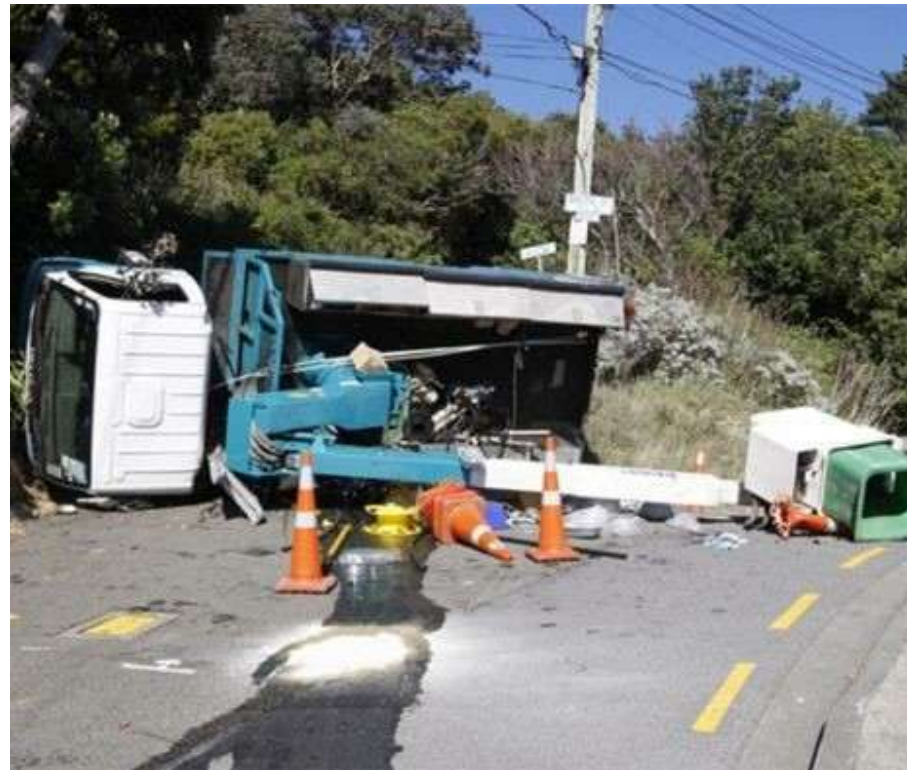
- A truck mounted platform over- turned as it took a bend in the road in Island Bay just south of Wellington.
- Property damaged, no injuries
- New Zealand

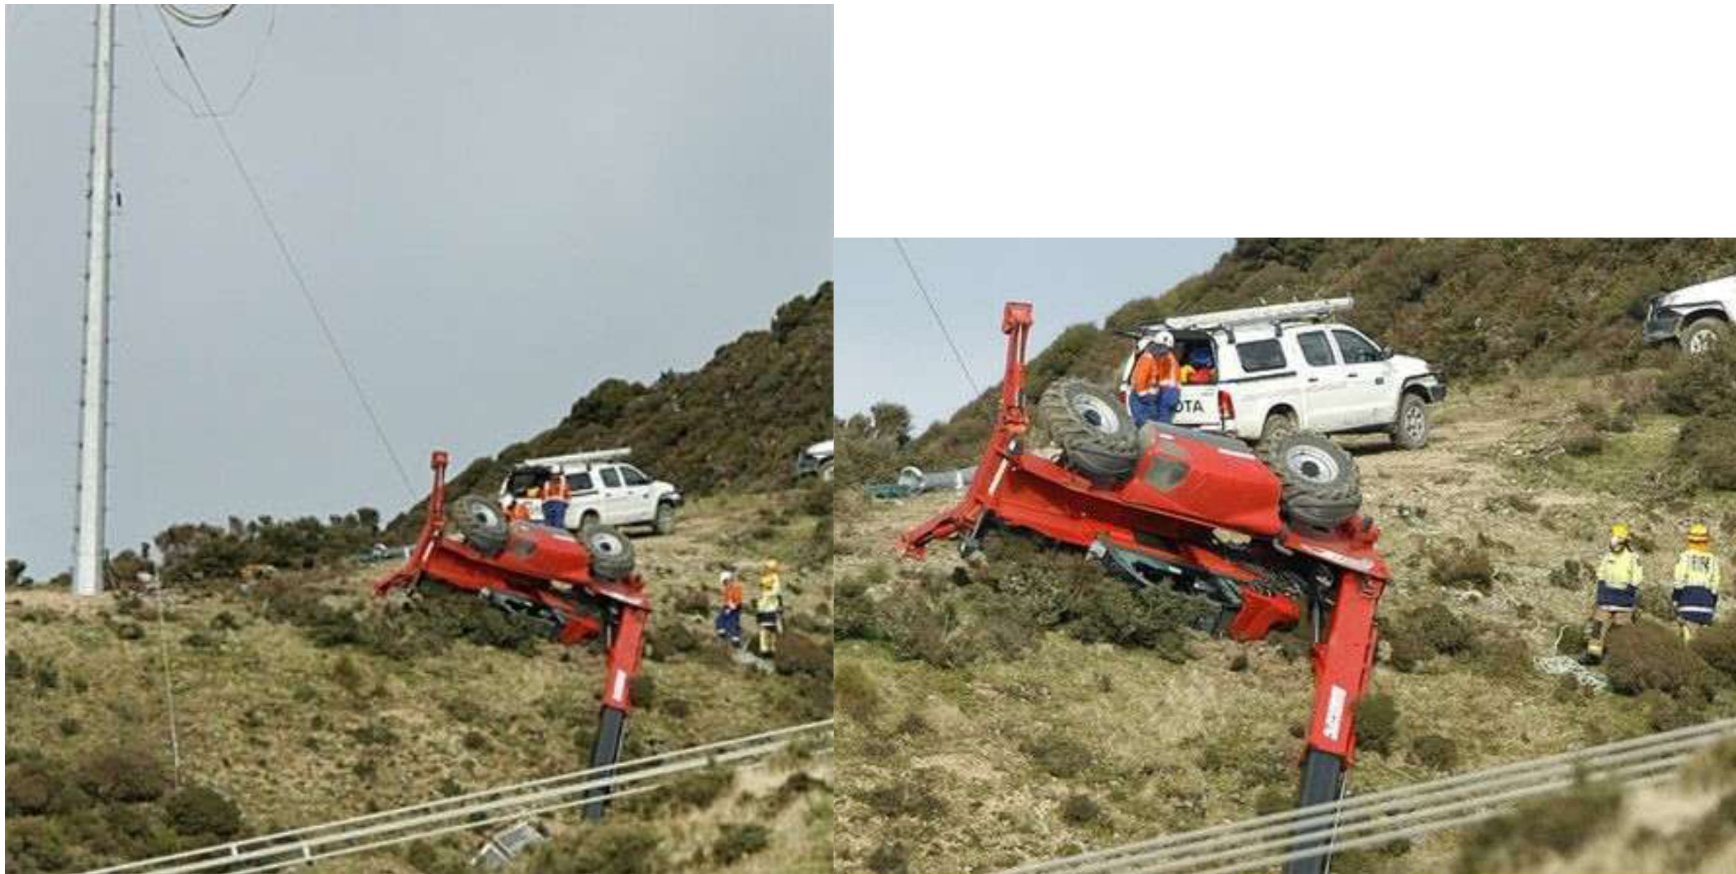
- Two men were working from a platform around 10 meters up when the lift ‘ran away’ and/or overturned. The men were properly harnessed and tied in, but the overturning caused fatal injuries to one man, while the other has been airlifted to hospital.
- One Fatality and one injured operator
- New Zealand.
