SAFETY GUIDANCE

20 September 2024

SUBJECT: WHEEL NUT TORQUE SETTING AND INSPECTIONS

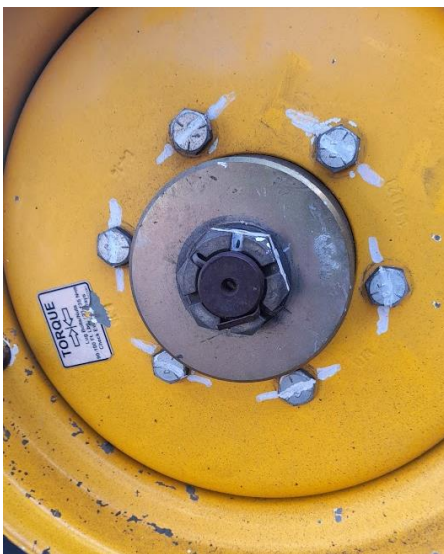
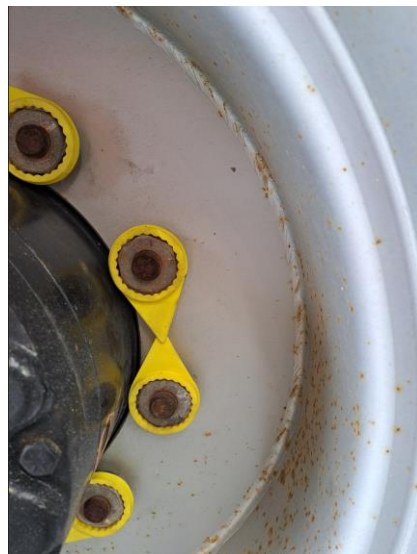
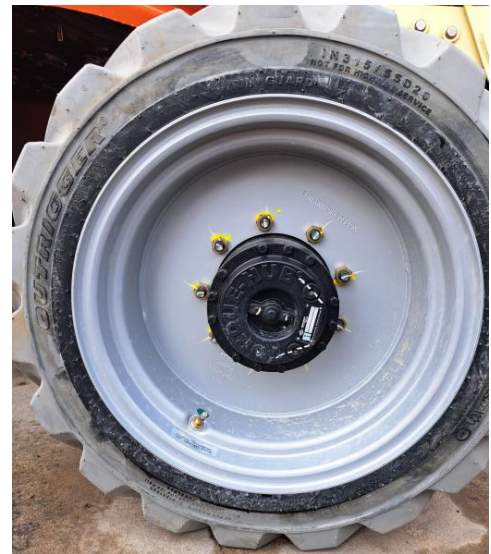
Below are examples of 'witness marks' and indicators on wheel nuts.

Where wheel nuts have been torqued to manufacturers specifications, wheel nut indicators or 'witness marks' should be added to the nut and rim for ease of checks and reference on whether a wheel nut 'worked itself loose'.
