The consequences of operating EWPs on inclines, soft ground and unsupported surfaces.

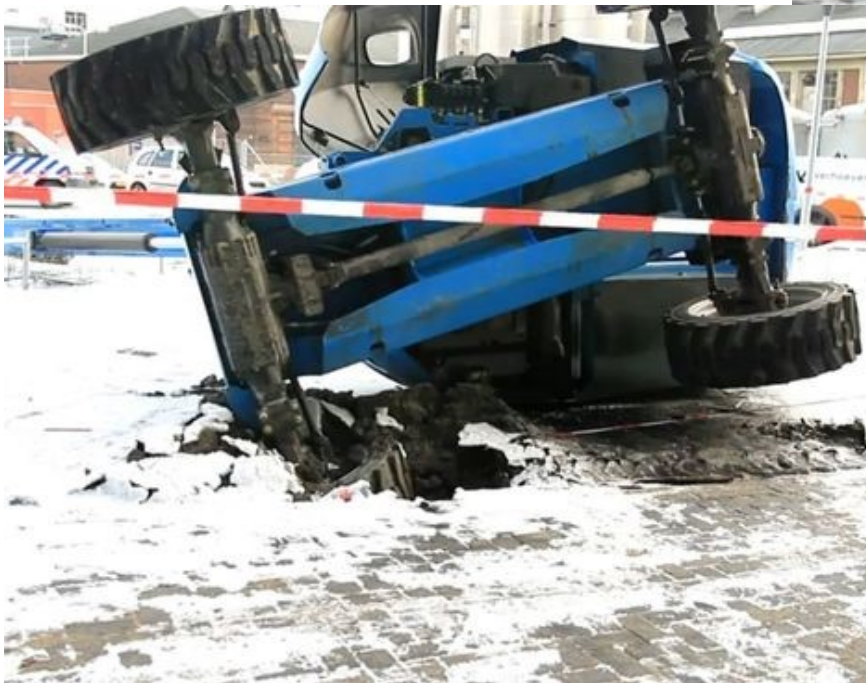
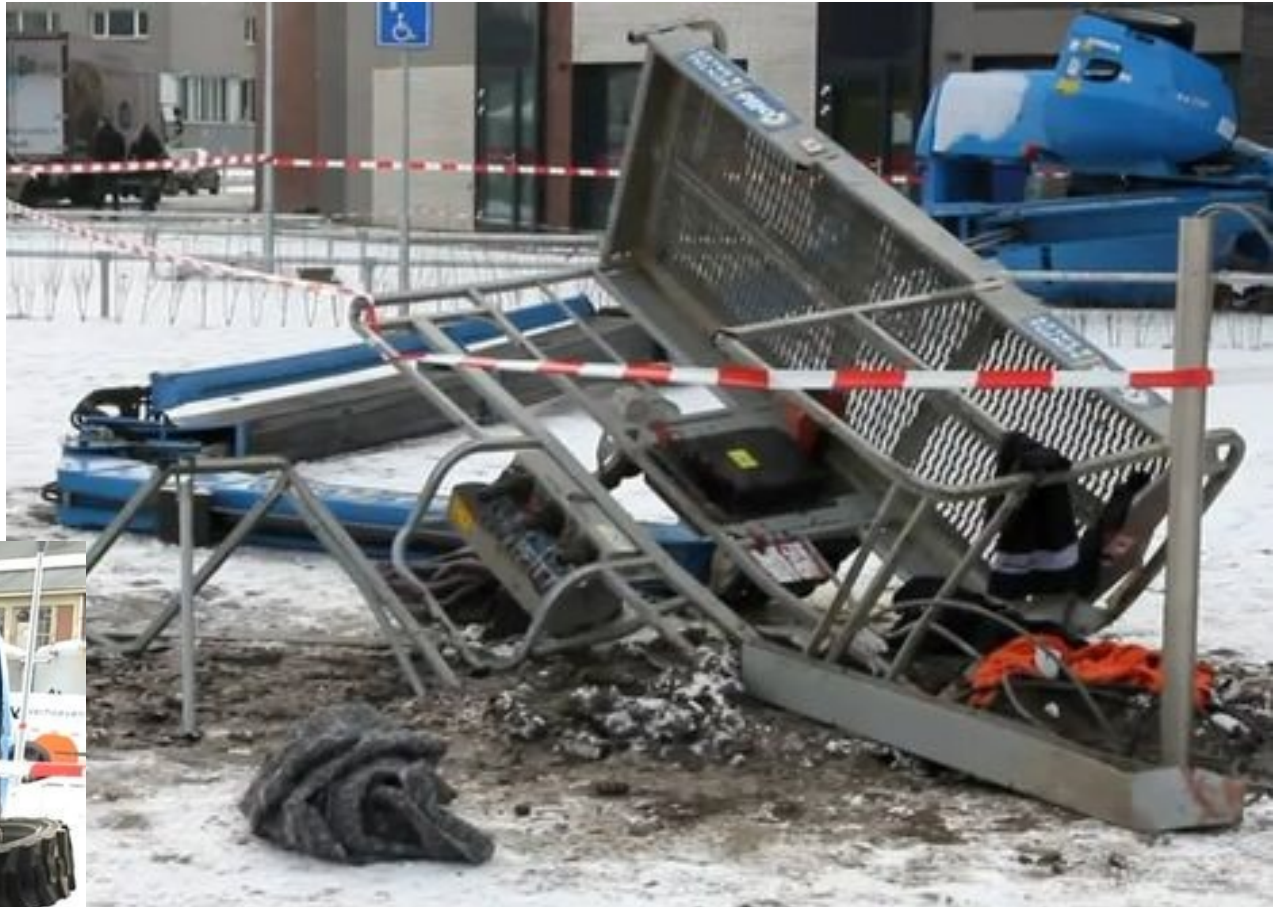
A boom lift overturned earlier today in Roosendaal, the Netherlands when the ground - gave way under one of its wheels.

With wheel loadings on a boom of this size easily exceeding four tonnes – concentrated by the unyielding poly filled tyres – it can prove to be too much for the interlocking blocks to support.

1 Injured operator. Netherlands.

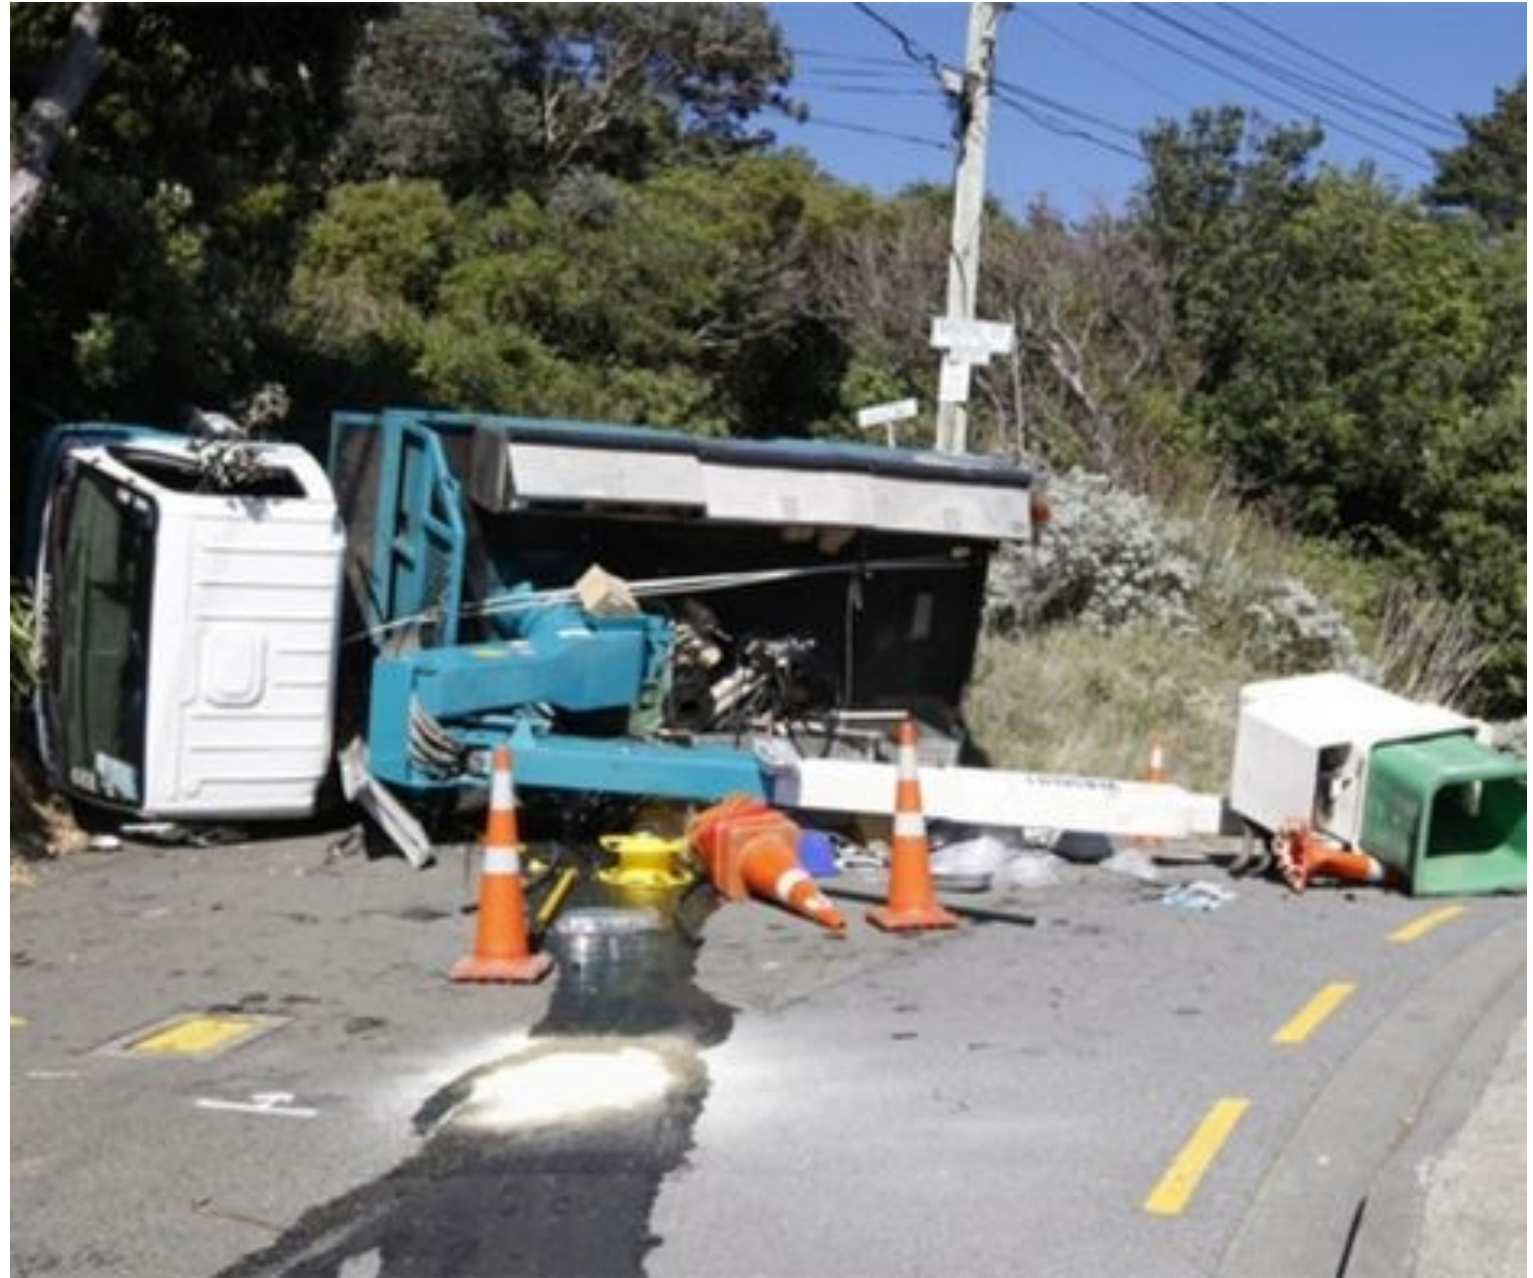
A truck mounted platform over-
turned as it took a bend in the
road in Island Bay, just south of
Wellington in New Zealand.

No Injuries. Property damage.
